# **Architectural Study**

# Building Analysis - Significance

# McVicar Creek - Harrington Court Heritage District

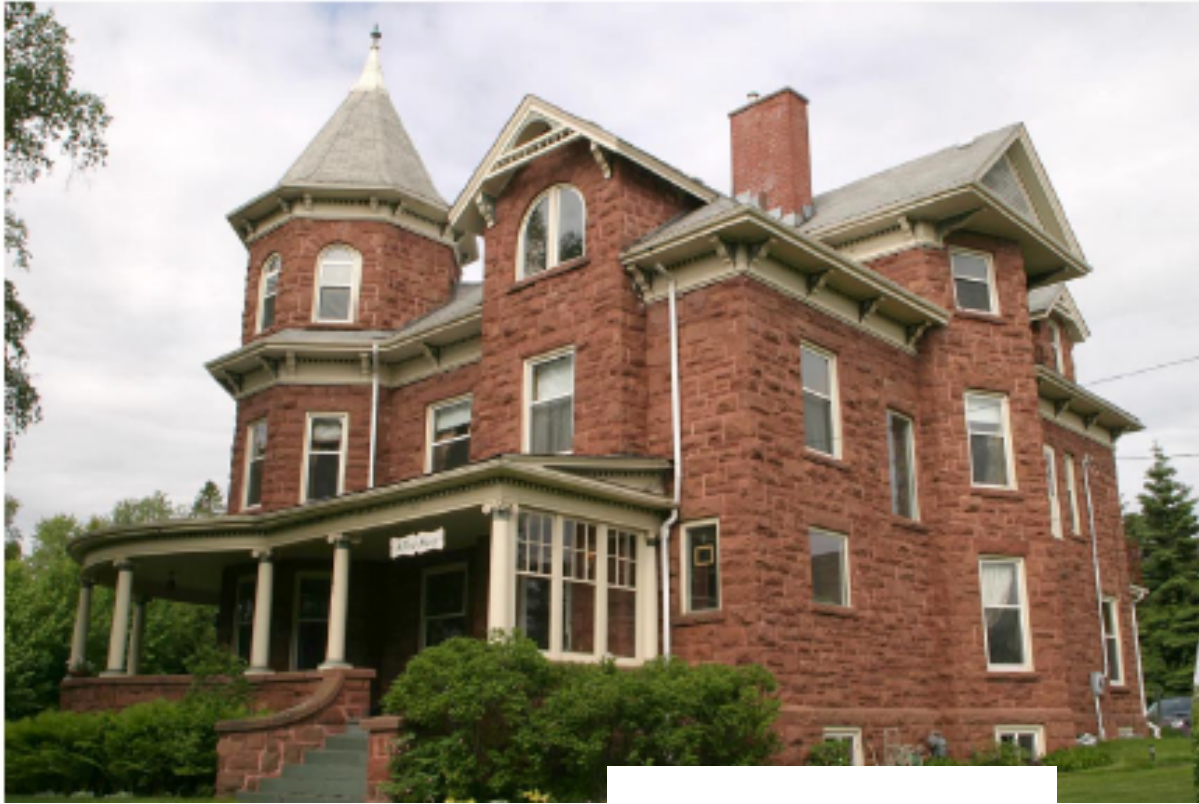
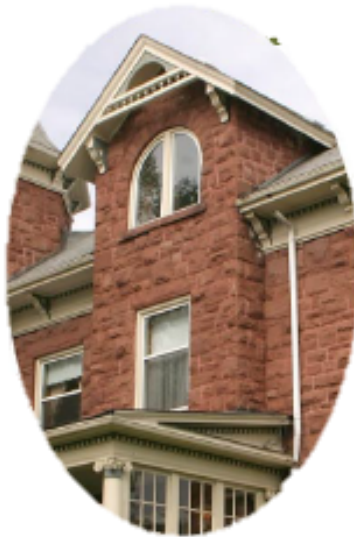
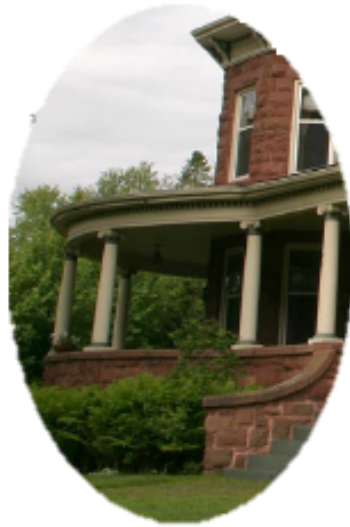
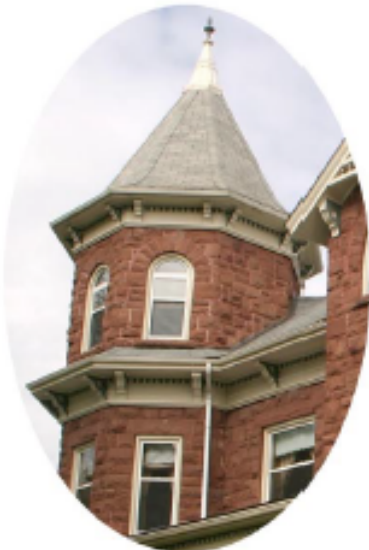
Example: 146 Court St. N.

**Significance  
Rating : A**

This building possesses a substantial degree of architectural and historic value. Louis Walsh was the original owner of this home and was built in 1906. Much of the original building materials have been retained is an excellent example of the craftsmanship of the era and contains interesting detailing. Such a building can be said to epitomize the flavour of the area.

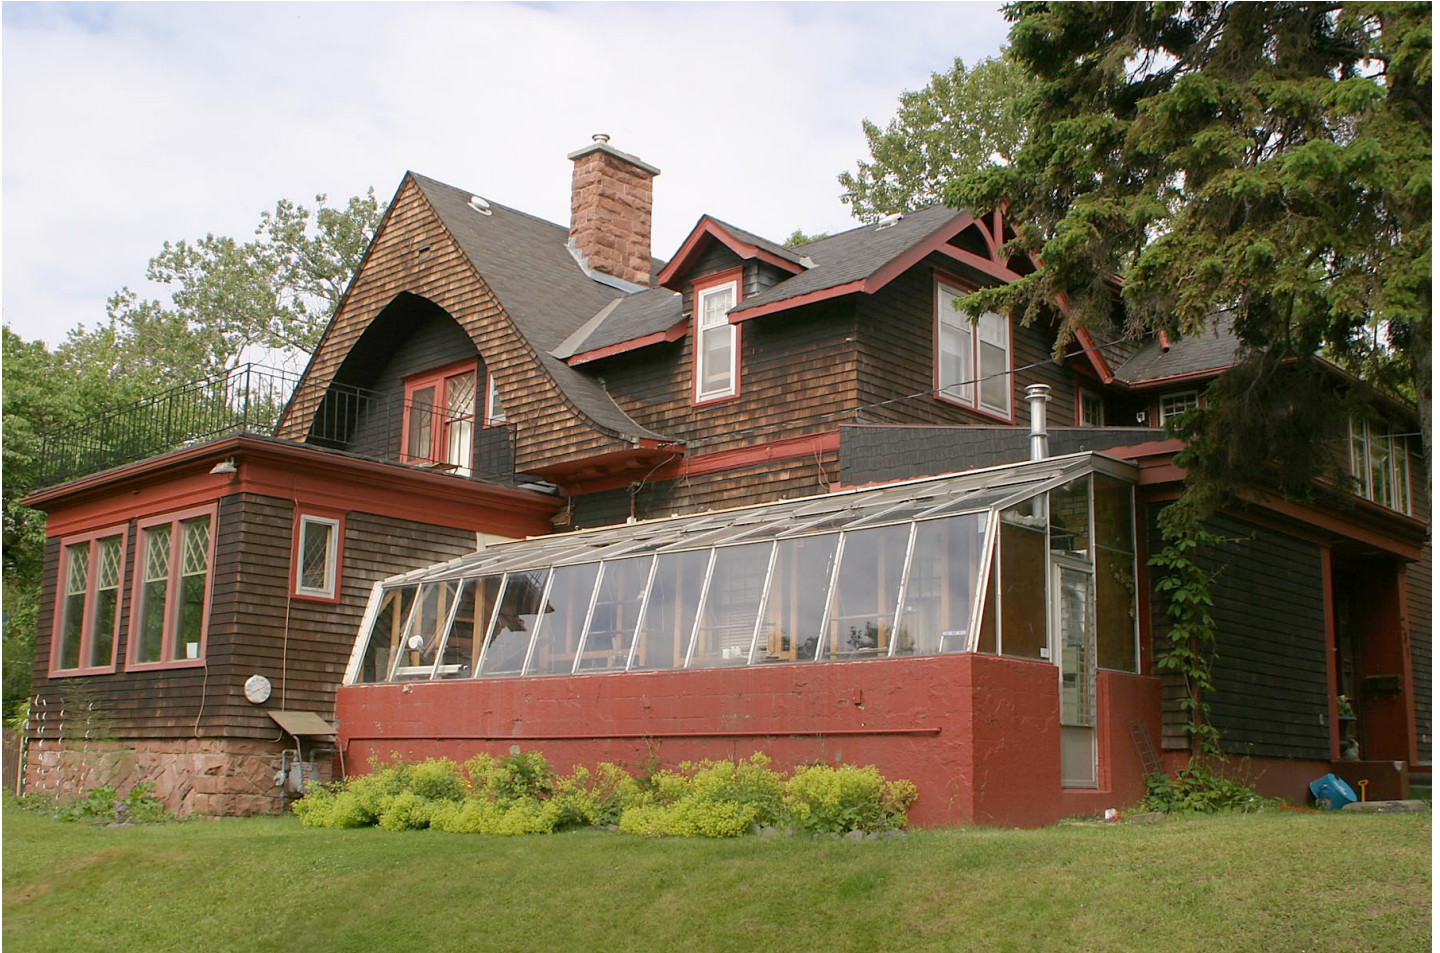
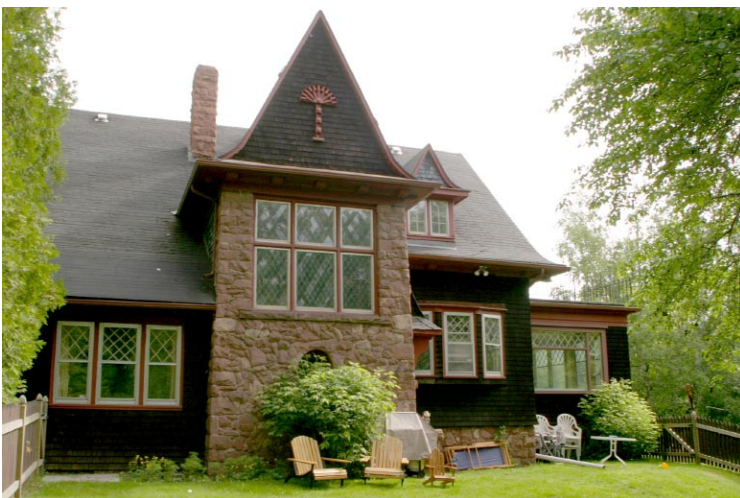
Example: 281 Ray Ct.

## Materials Rating: A

The surface materials of the building are of high quality in that it displays a substantial structural nature and superior care. The high quality of craftsmanship and materials used in the construction and maintenance of this home are very evident. Structural additions to the home have been well thought out and materials used were of the same quality as the original design.

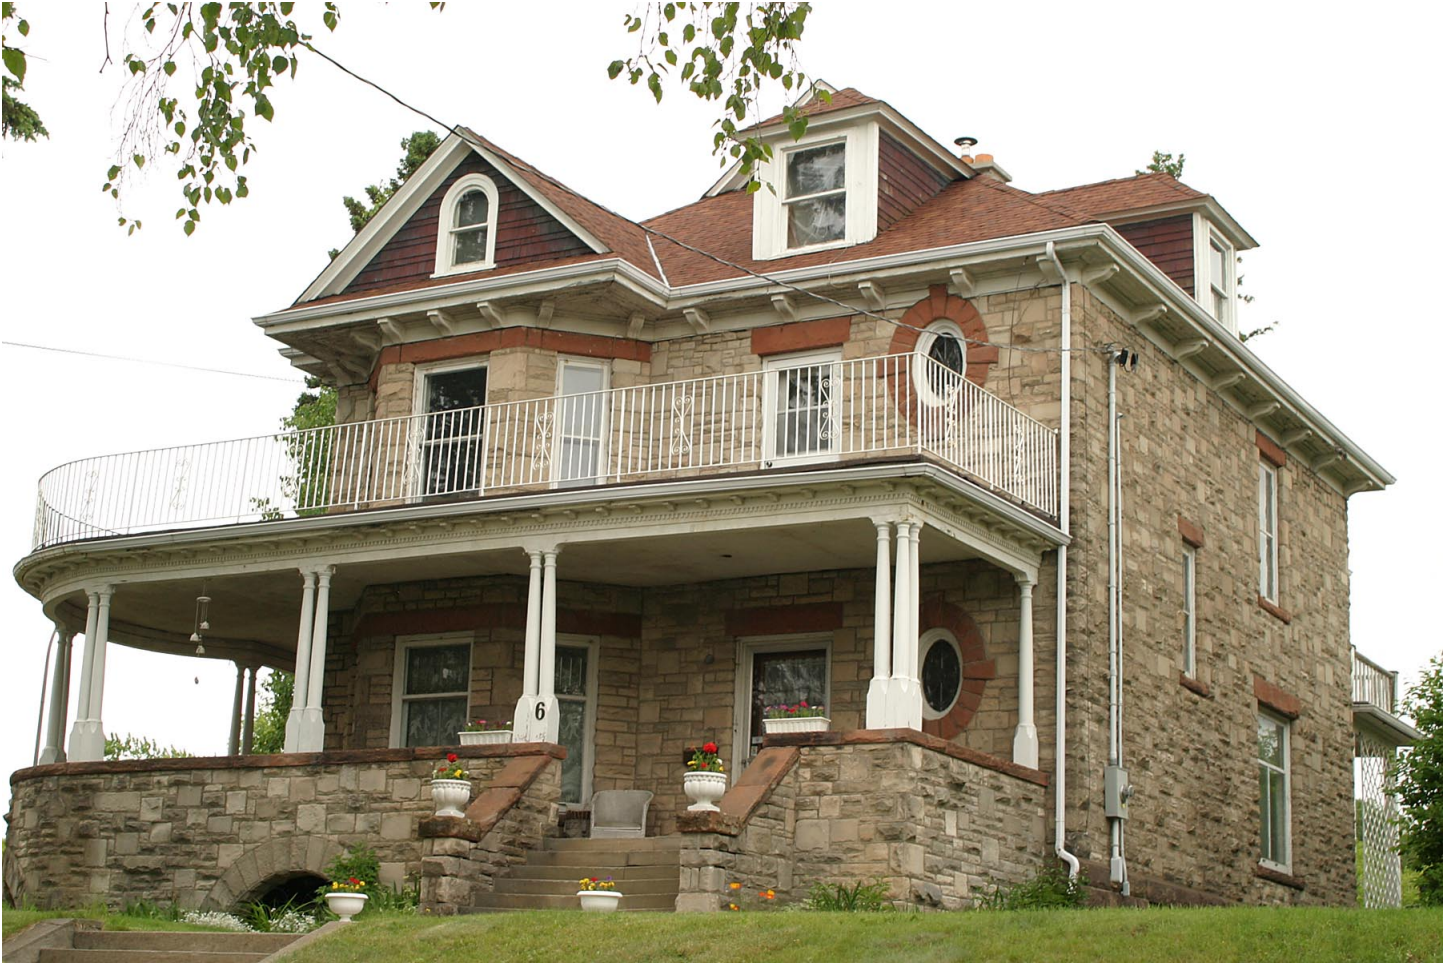
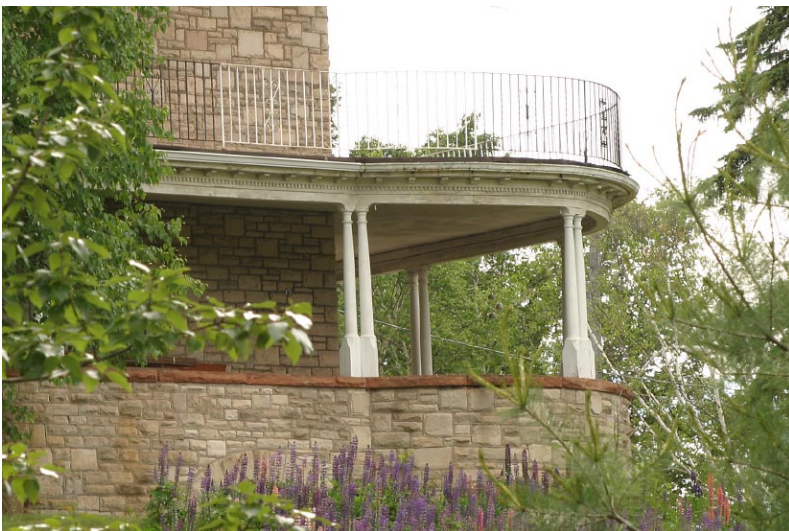
Example: 6 Emmerson Ave.

## Compatibility Rating: A

This building possesses the massing, scale and site considerations which add to the quality of the area. The orientation of this building on its property, the well maintained exterior and yard make this home highly compatible to other properties in the proposed heritage district. The wrap around verandah and detailed brickwork further demonstrates the architectural quality of the area.
