26 Nugent St.

## Architectural Analysis:

### 26 Nugent St.

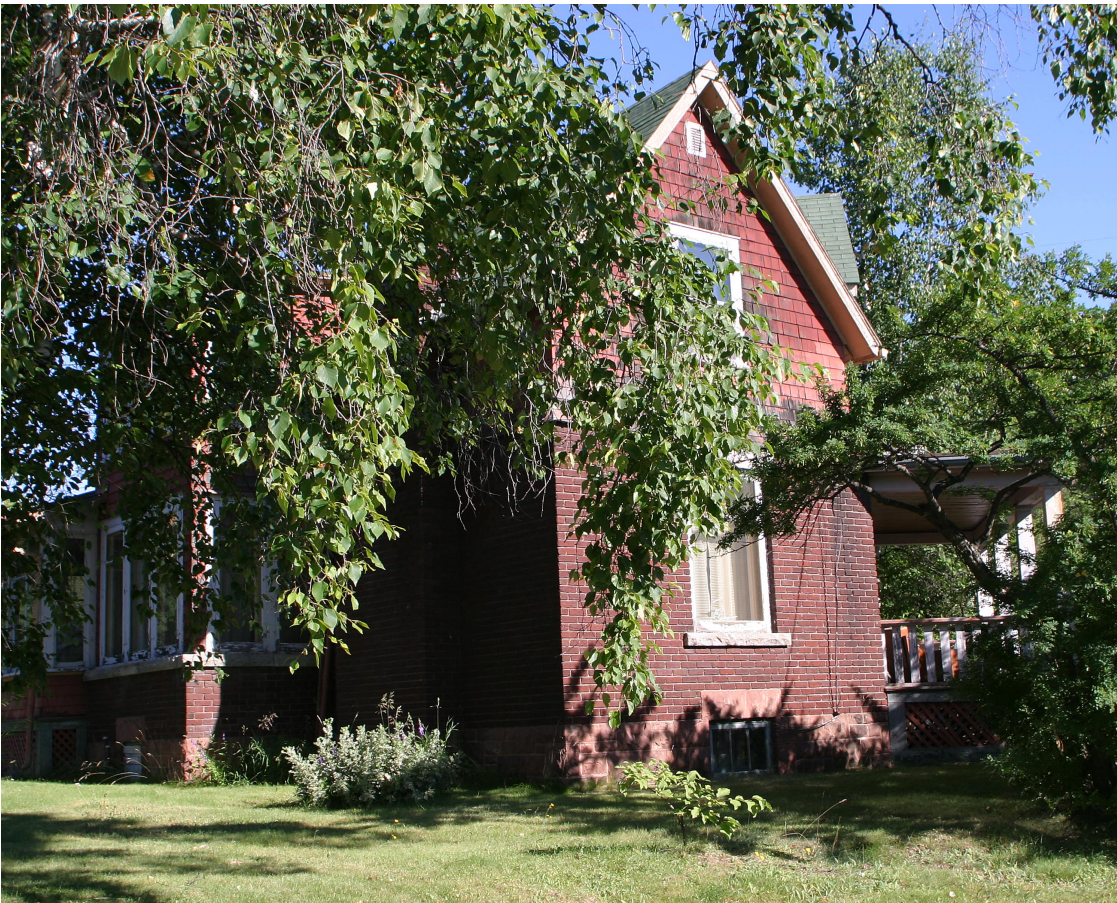
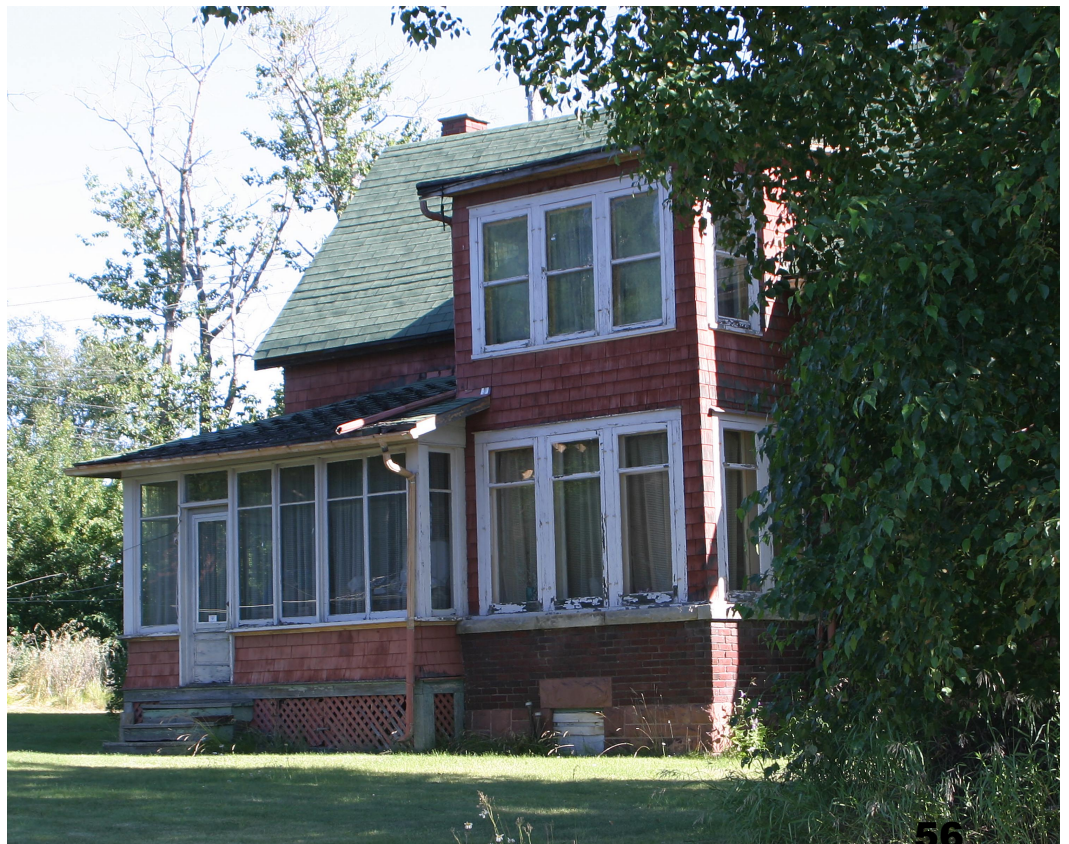
- 1 ½ storey
- The main floor's exterior walls are red brick except on the backside of the house (south side) where wood shingles are used to cover some of areas
- Red, cut stone is used at base of the house
- Front porch/verandah and gable on the northeast corner of the house is angled to face McVicar Creek. This unique design gives the overall shape of the house a pentagon formation
- The house has a sunroom and a two storey addition on the south side

- Wood shingles cover the exterior walls of the second storey

- The roof is a cross gable design type
- Asphalt shingles
- The gable on the north-east corner is on a 45 degree angle compared to the main roof gable
- Shed roof designs cover the porch, sunroom and the two storey addition
- Wood shingles cover the gable ends

- Windows are casement types in varying sizes. Some are single hung types

- A square window turned on a 45 degree angle is located near the top of the angled gable

- Sandstone window sills adorn some of the windows

- The home has two brick chimneys
- The house is poorly maintained and signs of aging are evident
- The shrubbery on the McVicar St. side of the home blocks the view of the front on the house
- A brick garage which once might have been the stable exists on the south side of the property
