288 Harrington Ave.

## Architectural Analysis:

### 288 Harrington Ave.

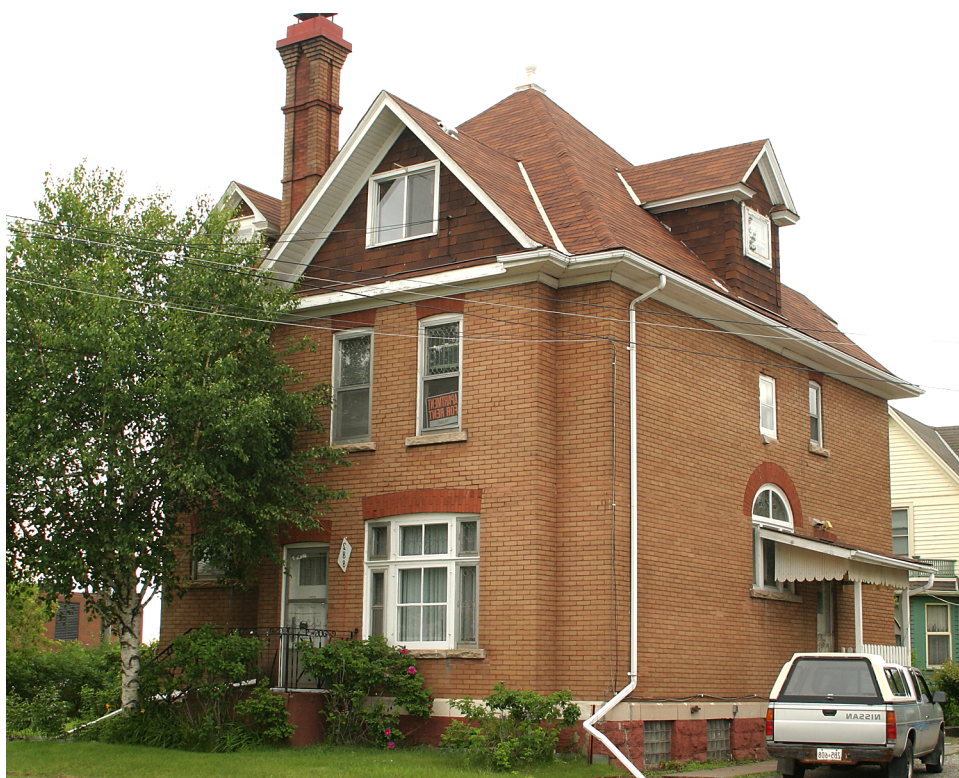
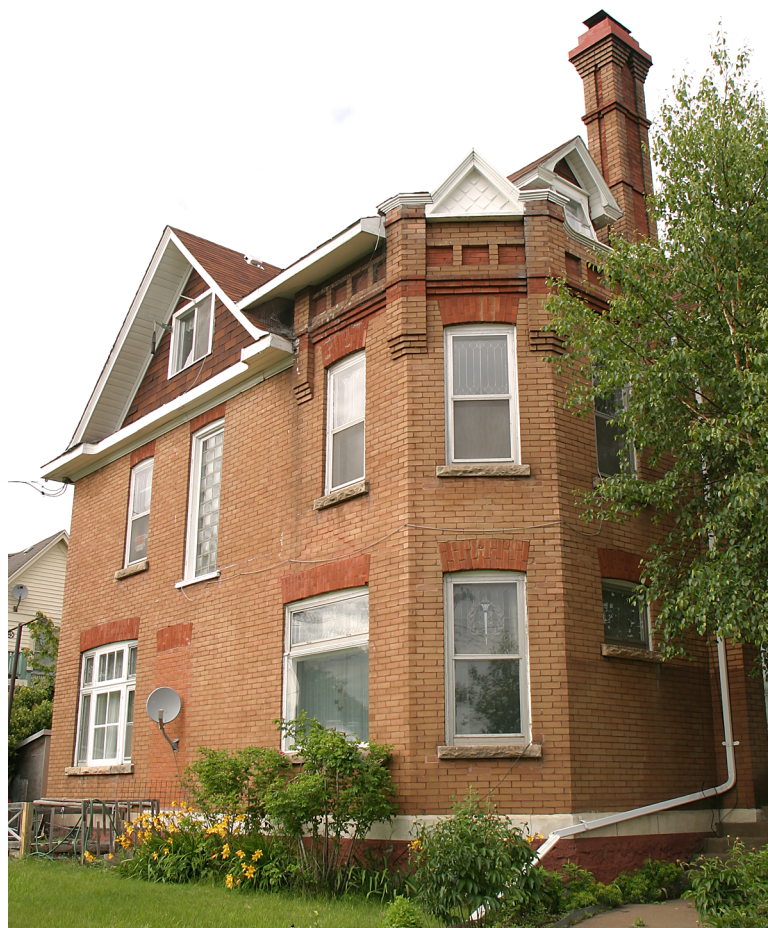
- 2 ½ Storey
- The exterior walls are brick veneer
- The front south-east corner of the home is angled to face the corner of the property.
- Detailed brickwork along the upper portions of the east and south walls – recessed and corbelled designs
- Vertical brickwork over the top of each window
- Arched brickwork frames an arched window on the west side of the house

- Sandstone window sills

- The main portion of the roof is a pyramidal design, but has two gabled hips on the south and west sides of the home
- Gabled dormers are located at the front (south) and west sides of the house as well
- Asphalt shingles on main roof
- Gable ends are covered with asphalt shingles
- There is a small gable that frames the top of the angled south-east corner of the home and the gable

end is covered with wood shingles in a geometric pattern

- This building has a variety of different windows – double and single hung, sliding, casement, fixed, ribbon, arched, and block type designs

- This home has an intricately designed chimney with a corbelled top
- The angled south east corner of the home makes the house unique in the area
