# SCHEDULE C MUNICIPAL CLASS ENVIRONMENTAL ASSESSMENT

Environmental Study Report  
for the Rehabilitation of the Boulevard Lake Dam

December 2018

Arcadis Canada Inc.

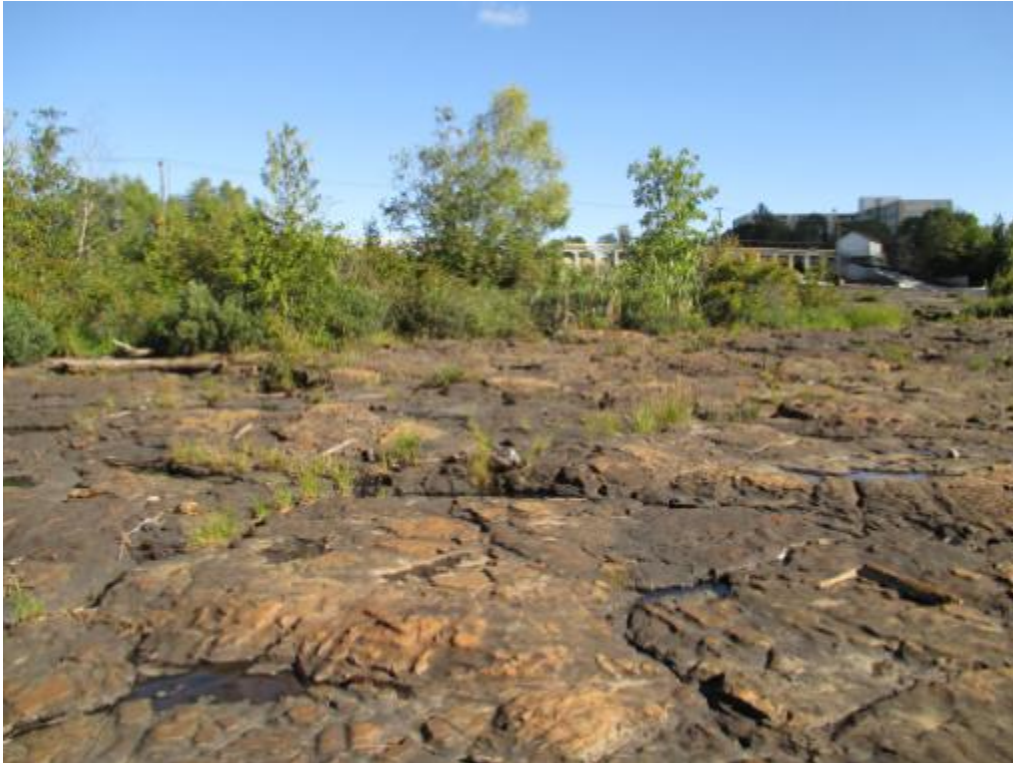
**Figure 3-5 North Part of Proposed Access Road Showing Rock Barren on River Floodplain**

Rock barren (Ecosite 160; OMNR 2009) occurs on the bedrock shelf below the dam (Figure 3-5). This area is scoured by water flowing over the dam during high flows but is typically exposed for most of the year (Foster 2011).

High flows have washed away most soil, organic material, sand and gravel. Patches of sedges and Sweet Gale are confined to a few deeper crevices. Some pools of standing water persist through the summer.

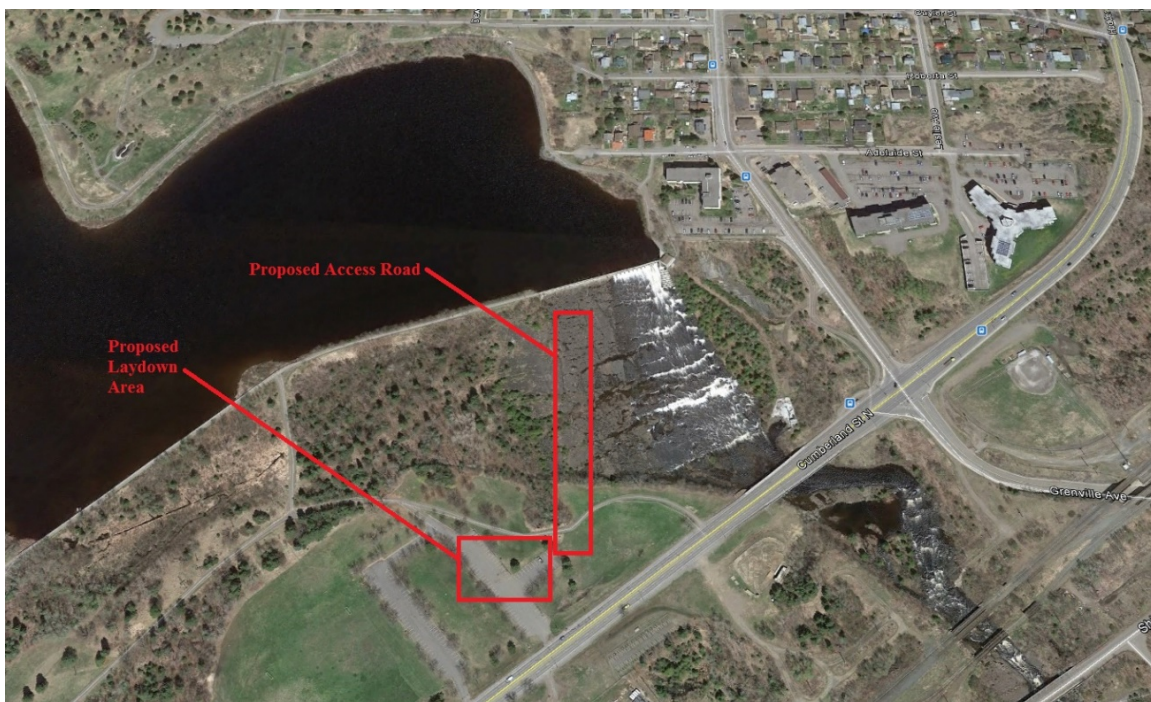
**Figure 6-1 Location of Proposed Laydown Area and Access Road**

Figure 6-1 below shows the proposed laydown area and access road. The laydown area for the contractor will be in the parking lot located off of Cumberland Street, south of the dam. An access road will be constructed from the parking lot to the downstream side of the dam, through the wooded area and across the exposed bedrock. The construction of the access road will follow best construction methods for erosion mitigation and minimal site disturbance. Relevant environmental standards will be followed. There are no other reasonable alternatives.

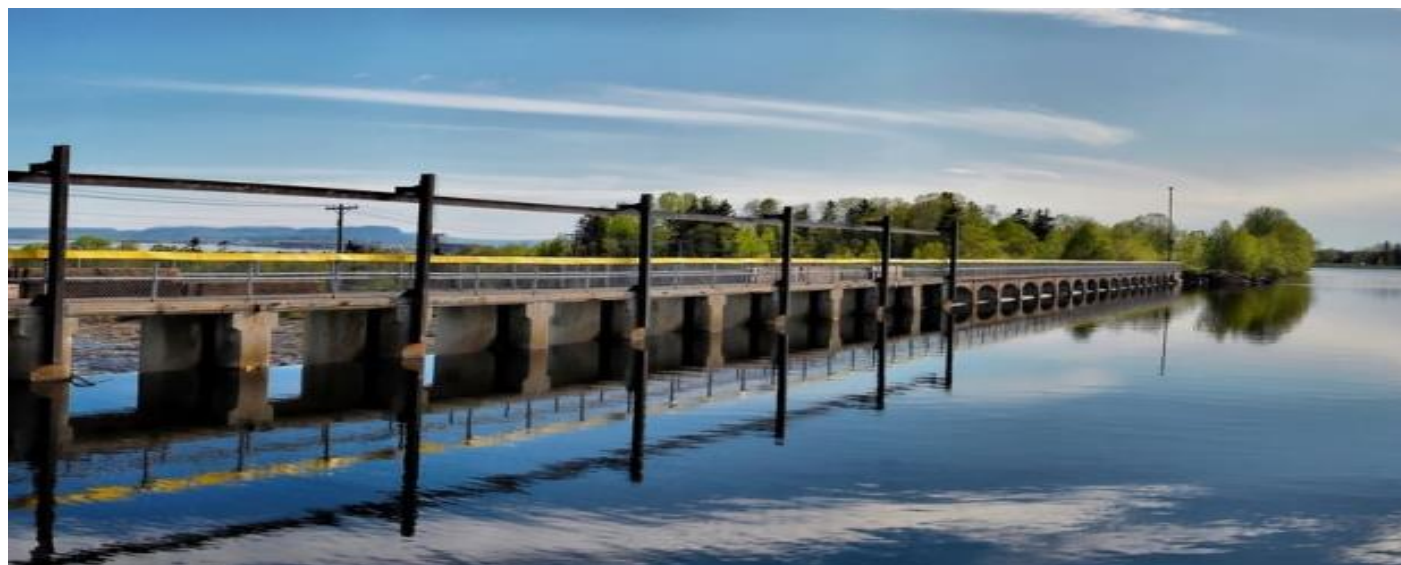
# Boulevard Dam - Overview

- Built approximately 100 years ago
- Owned and operated by the City of Thunder Bay
- Associated waterpower facility is operated by Current River Hydro Partnership under a lease from the City of Thunder Bay
- Located approximately 700 m upstream of where the Current River discharges into Lake Superior
- The existing dam structure is approximately 112 m long and is oriented in an east/west direction
- Concrete construction with a series of concrete spillways and a series of log controlled sluiceways
- East approach is concrete retaining wall and west approach is 440 m rock berm

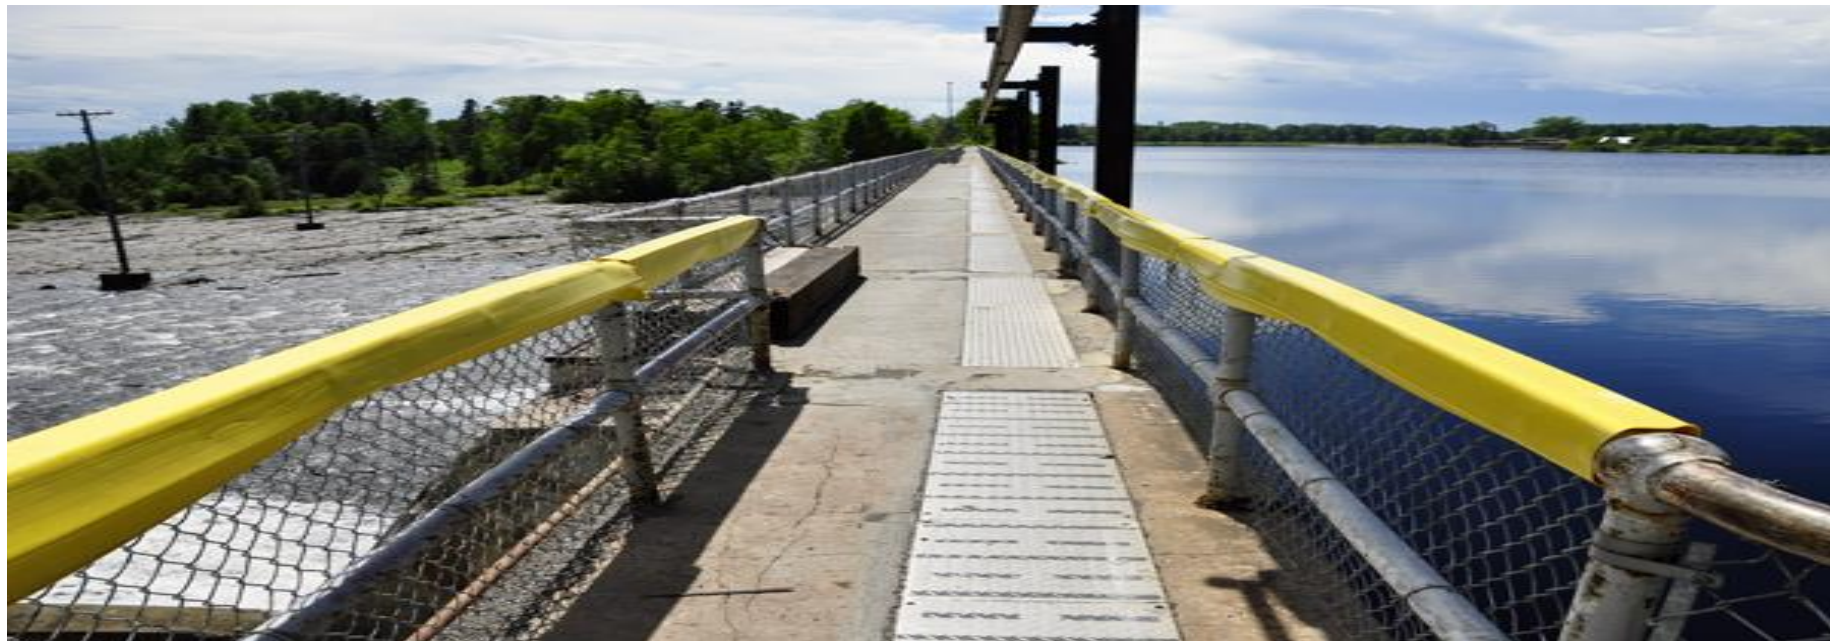
# Boulevard Dam - Overview

- 1960s post tension anchors installed in each buttress to address risk of floodwaters associated with regulatory storm event
- 1990's Fish ladder installed to facilitate movement of Steelhead for spawning upstream
- Walkway on top of dam used as part of trail system
- Dam created Boulevard Lake which is a recreational resource used by residents
- The Boulevard Lake Dam is operated twice a year outside of actions taken during isolated weather events and maintenance requirements; water levels are drawn down in fall and raised in summer

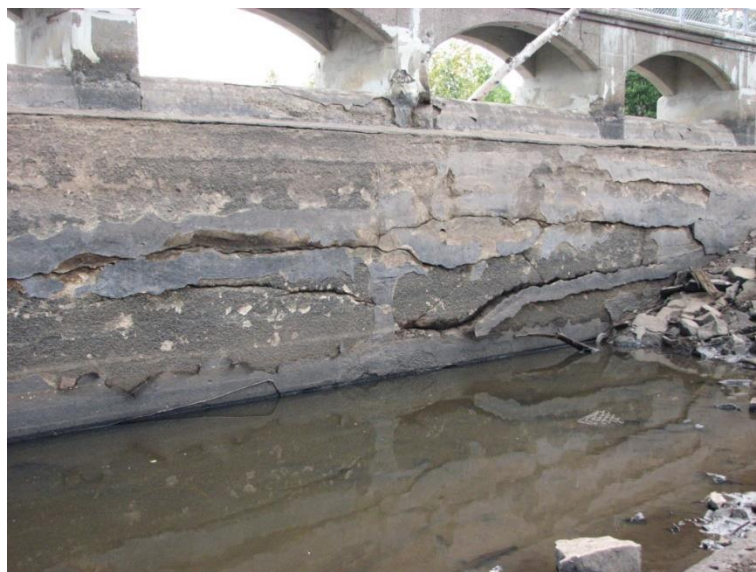
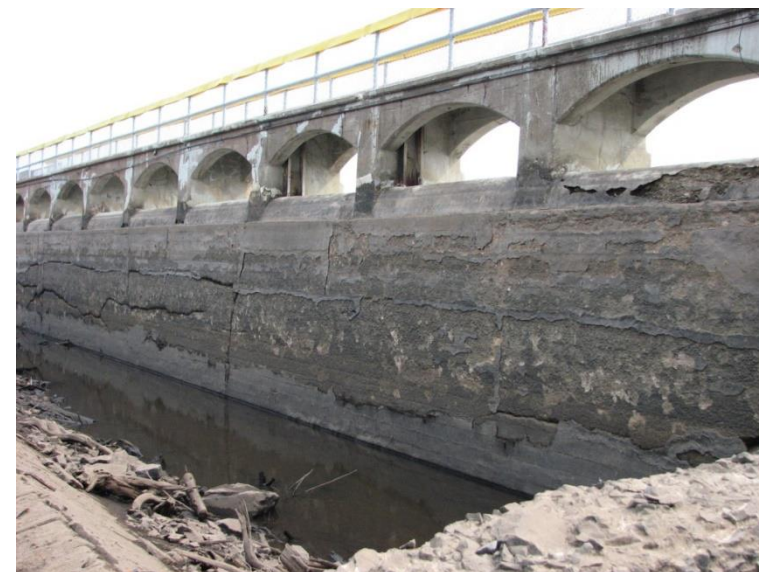
# Problem Assessment

- Protective concrete at exterior of dam infrastructure is deteriorating and needs rehabilitation
  - Severe spalling and delamination of the east retaining wall
  - Severe cracking and significant separation of the upstream concrete facing wall at the spillways
  - Soft concrete, spalling, delamination, and erosion at numerous buttress locations
  - Significant spalling, cracking, and erosion throughout the spillway and sluiceway aprons, and at the spillway slab
  - Spalling of the concrete slabs at the existing railing post locations and at a few locations at the underside of the sluiceway slabs
  - Severe longitudinal cracks at the spillway slabs
- Structural strength of dam is not sufficient to meet *Lake and Rivers Improvement Act (LRIA)* requirements for redundancies, should there be a regulatory storm event

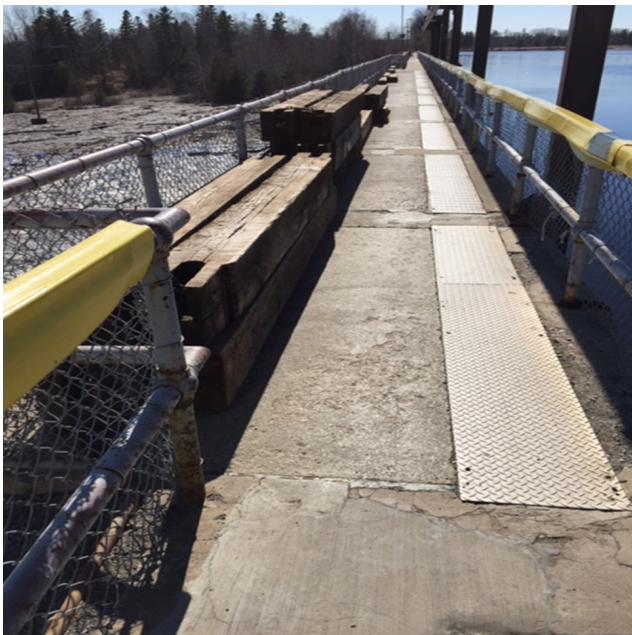
Walkway and Stop Logs

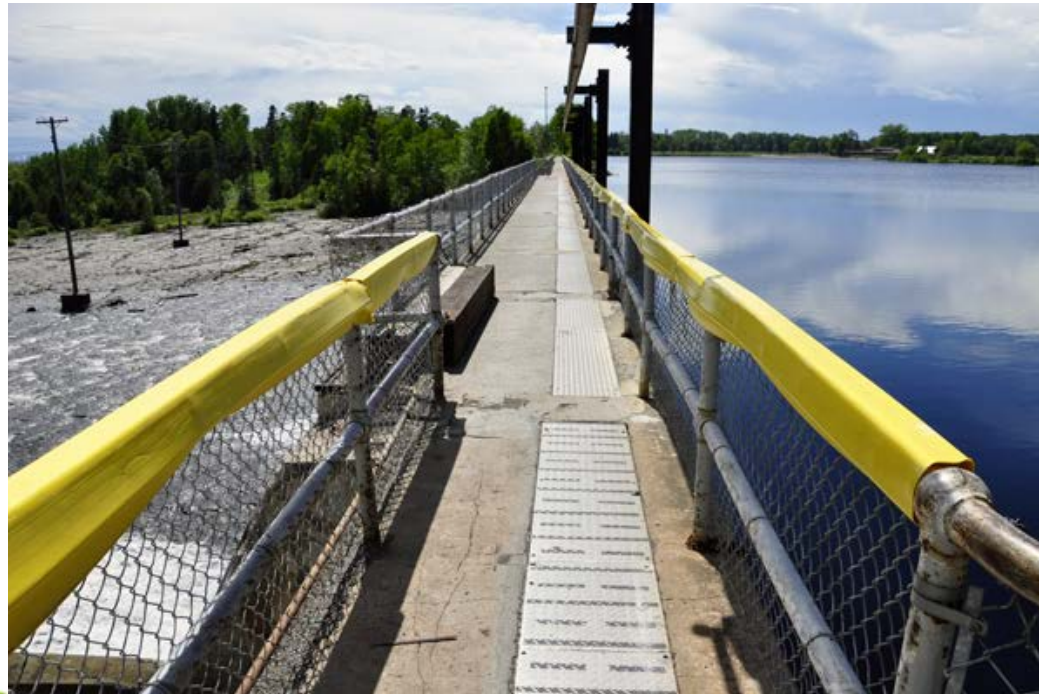
- 1970s post tension anchors installed in each buttress to address risk of floodwaters associated with regulatory storm event
- Fish ladder installed to facilitate movement of Steelhead Salmon for spawning upstream
- Walkway on top of dam used as part of trail system
- Dam created Boulevard Lake which is a recreational resource used by residents
- The Boulevard Lake Dam is operated twice a year outside of actions taken during isolated weather events and maintenance requirements. Water levels are drawn down in fall and raised in summer.

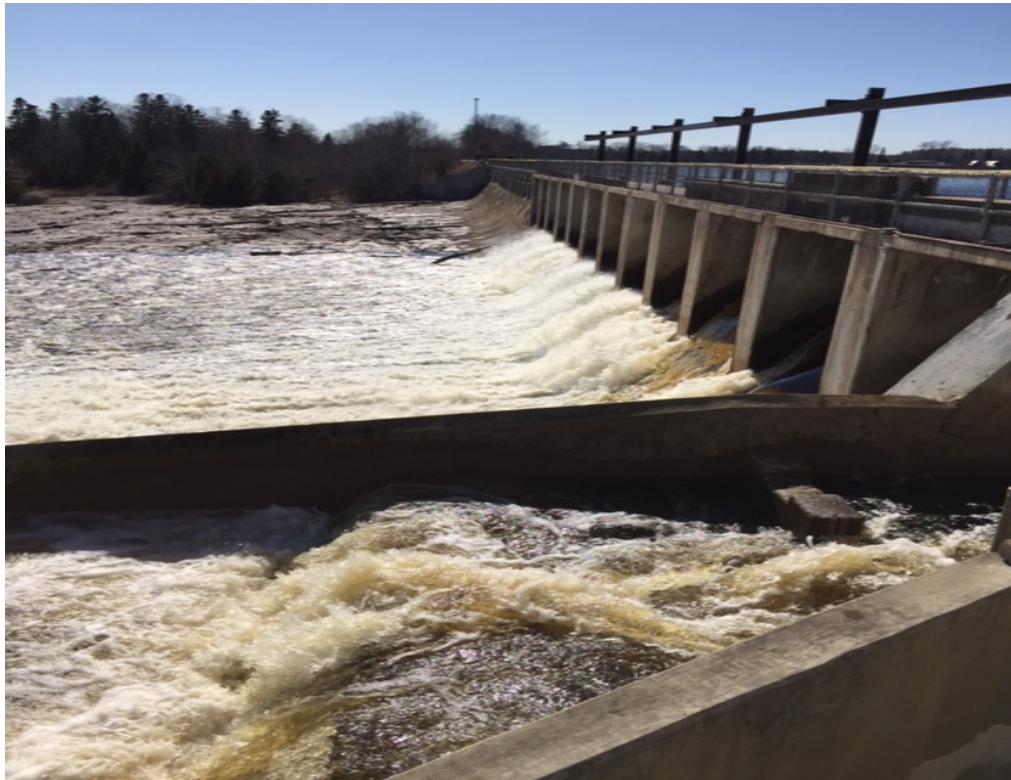
Upstream side; Sluice Gates

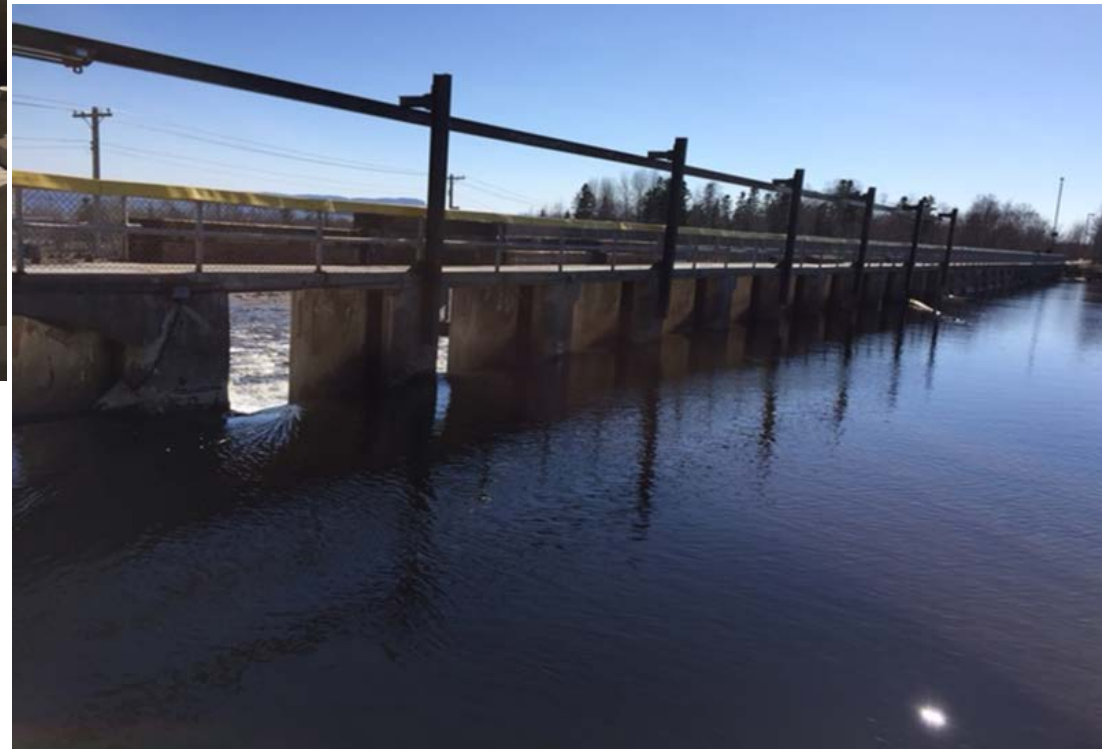
Downstream; Sluice Gates

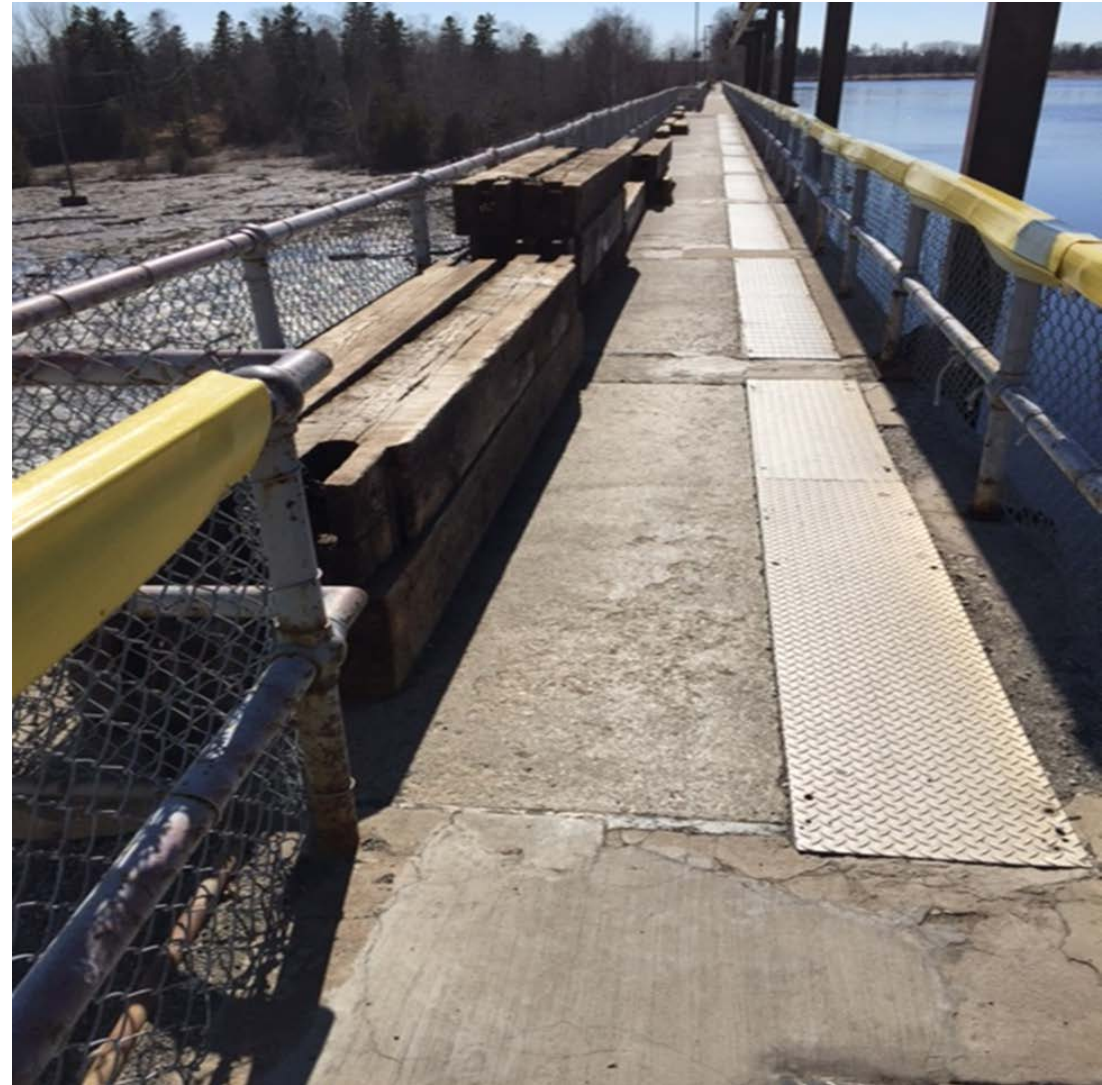
Walkway and Stop Logs

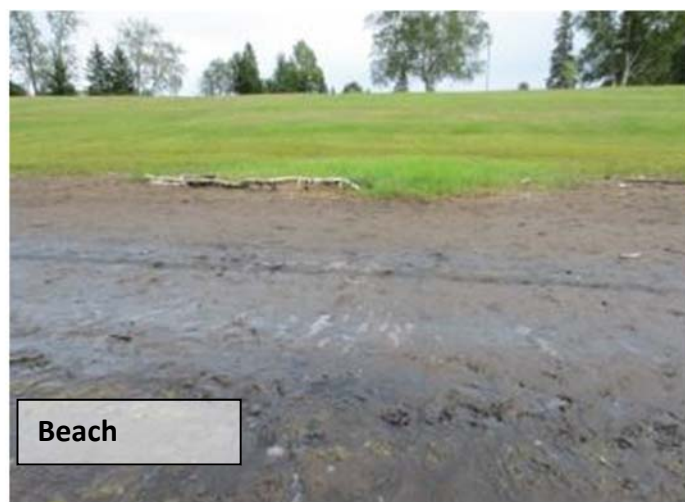
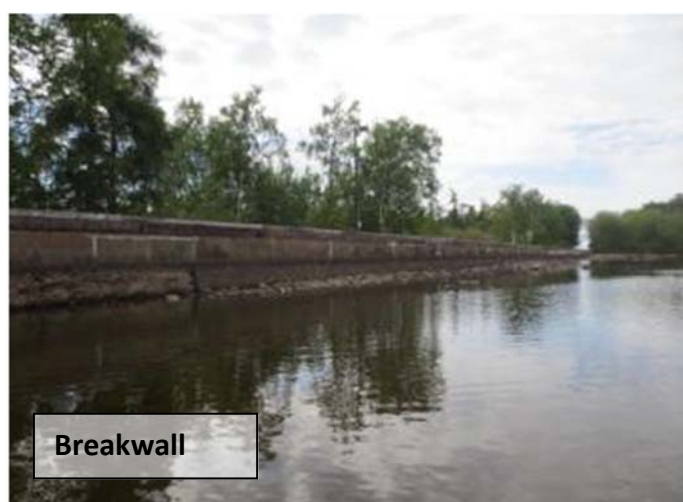
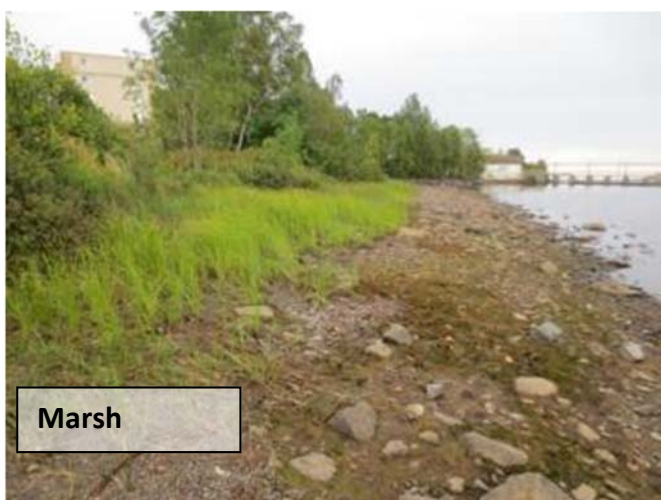
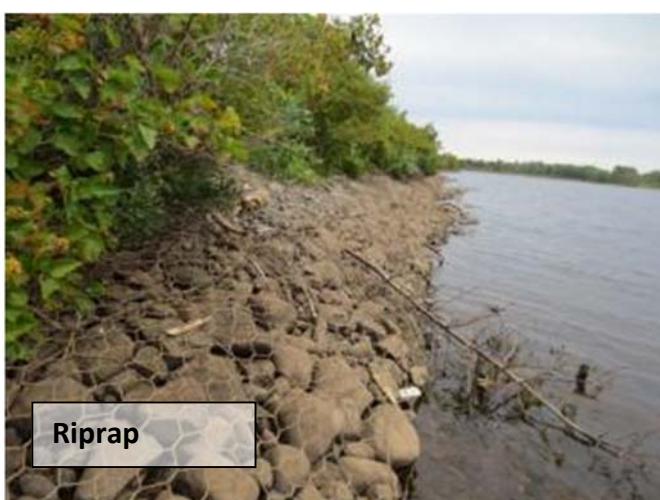
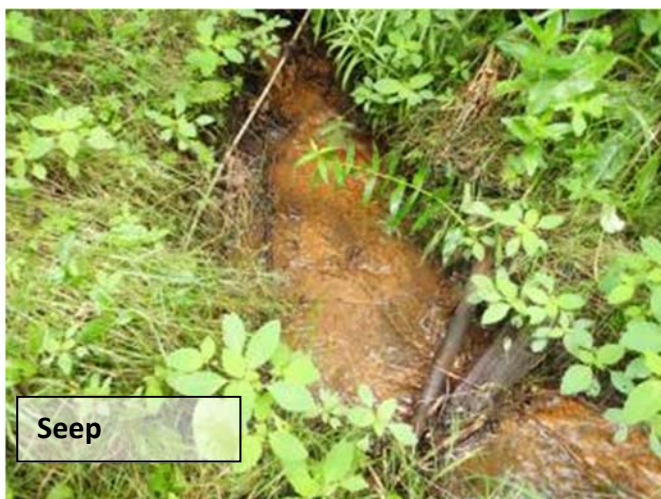
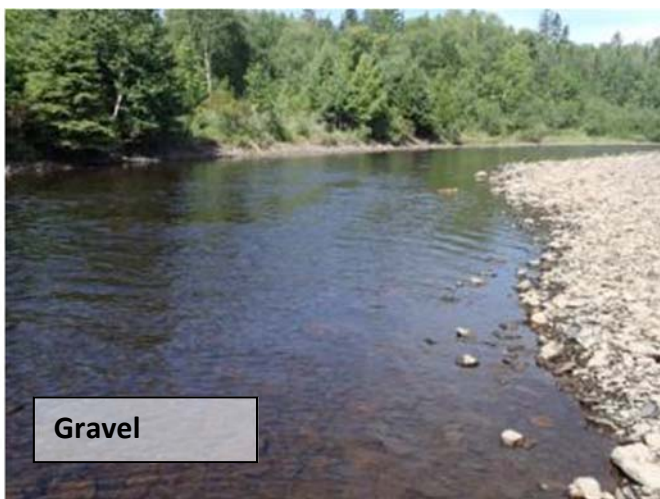
Figure 4. Shoreline habitat classes. Boulevard Lake 2016.

About a third of the shoreline is marsh, concentrated at the north end of the lake (Figure 14, Table 2). Most of the marsh consists of a narrow fringe of sedges (*Carex* spp.) or cattail (*Typha* spp.) backed by lawn or forest (Figure 4). A few larger patches of emergent marsh are found near the inflow of the Current River. Many of the marshes are flooded during high water but do not extend into the lake and are therefore inaccessible to fish when water levels drop during winter drawdown and summer low water events. A small wetland (about 0.4 ha) with cattail marsh and submergent vegetation occurs in a basin on the east side of the lake. The marsh is connected to Boulevard Lake through a culvert when the lake level is high, but more or less isolated during low water.

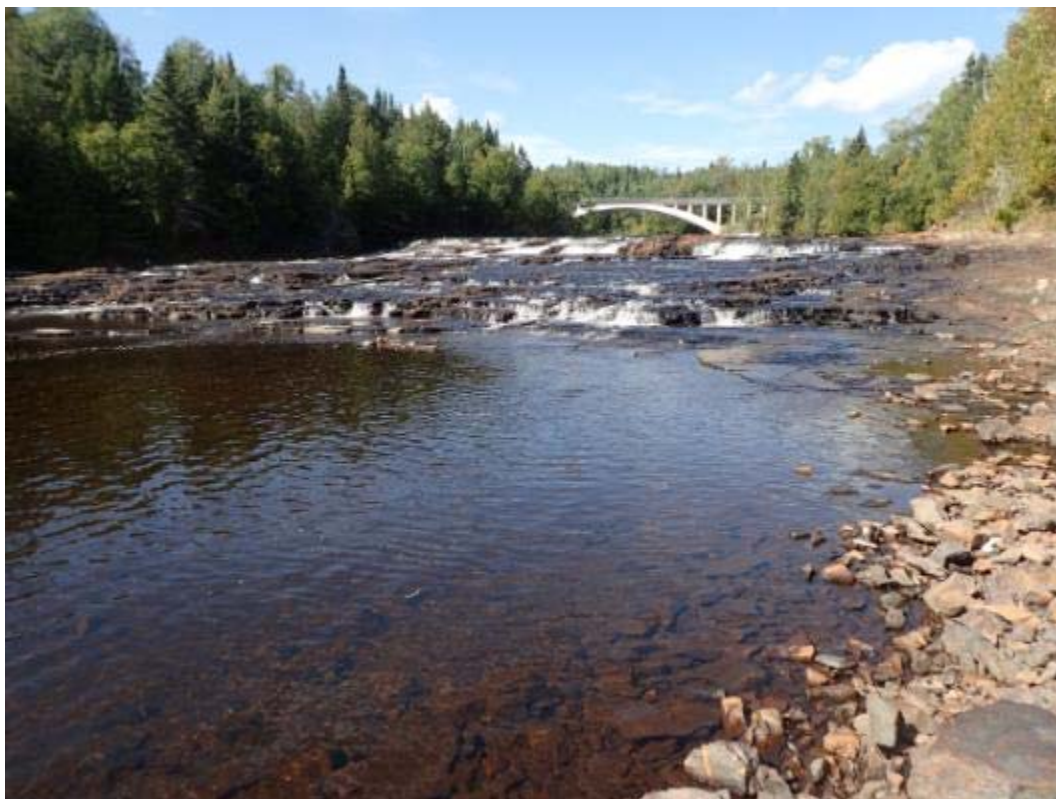
**Figure 5. Bedrock shelf at the mouth of the Current River at the north end of Boulevard Lake.**

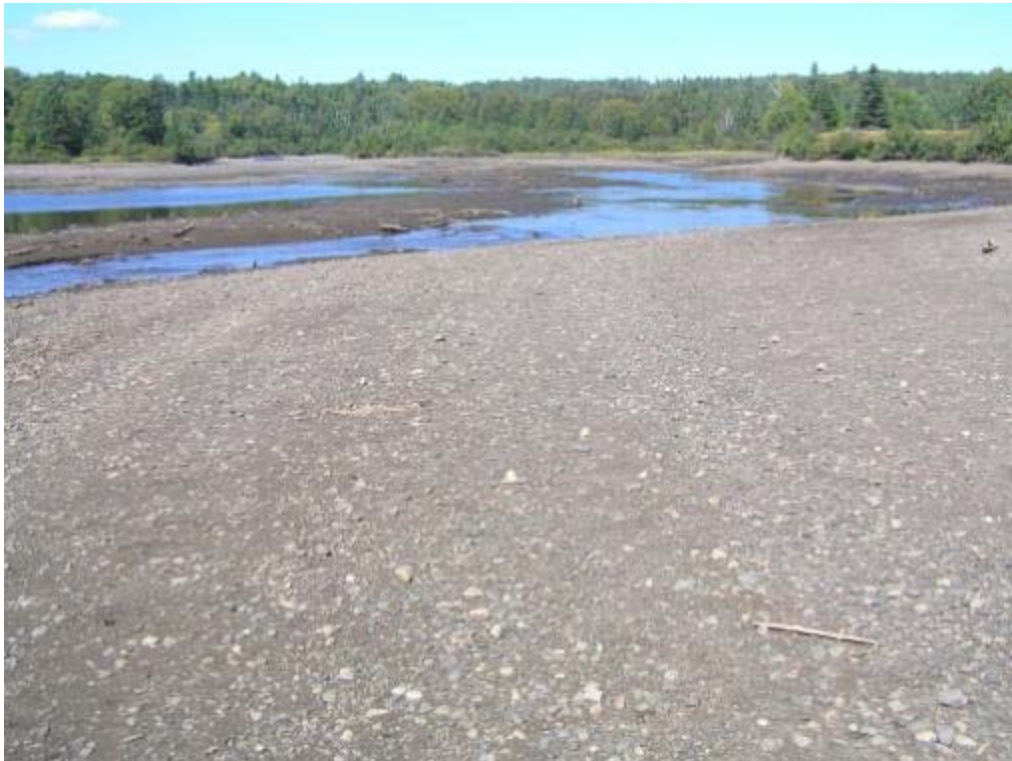
**Figure 6. Boulevard Lake during drawdown on August 30 2008 showing the Current River channel.**

During dam repairs, Option 1 would see the lake level drop to 208.34 m, resulting in a decrease in lake surface area to about 3.1 ha. Most of the lake will be exposed during dam repair except for the original location of the Current River channel (Figure 9). The approximate location of the channel is shown in Figure 9. Figure 6 shows a photo of the channel in August 2008 when a drawdown of similar magnitude occurred.

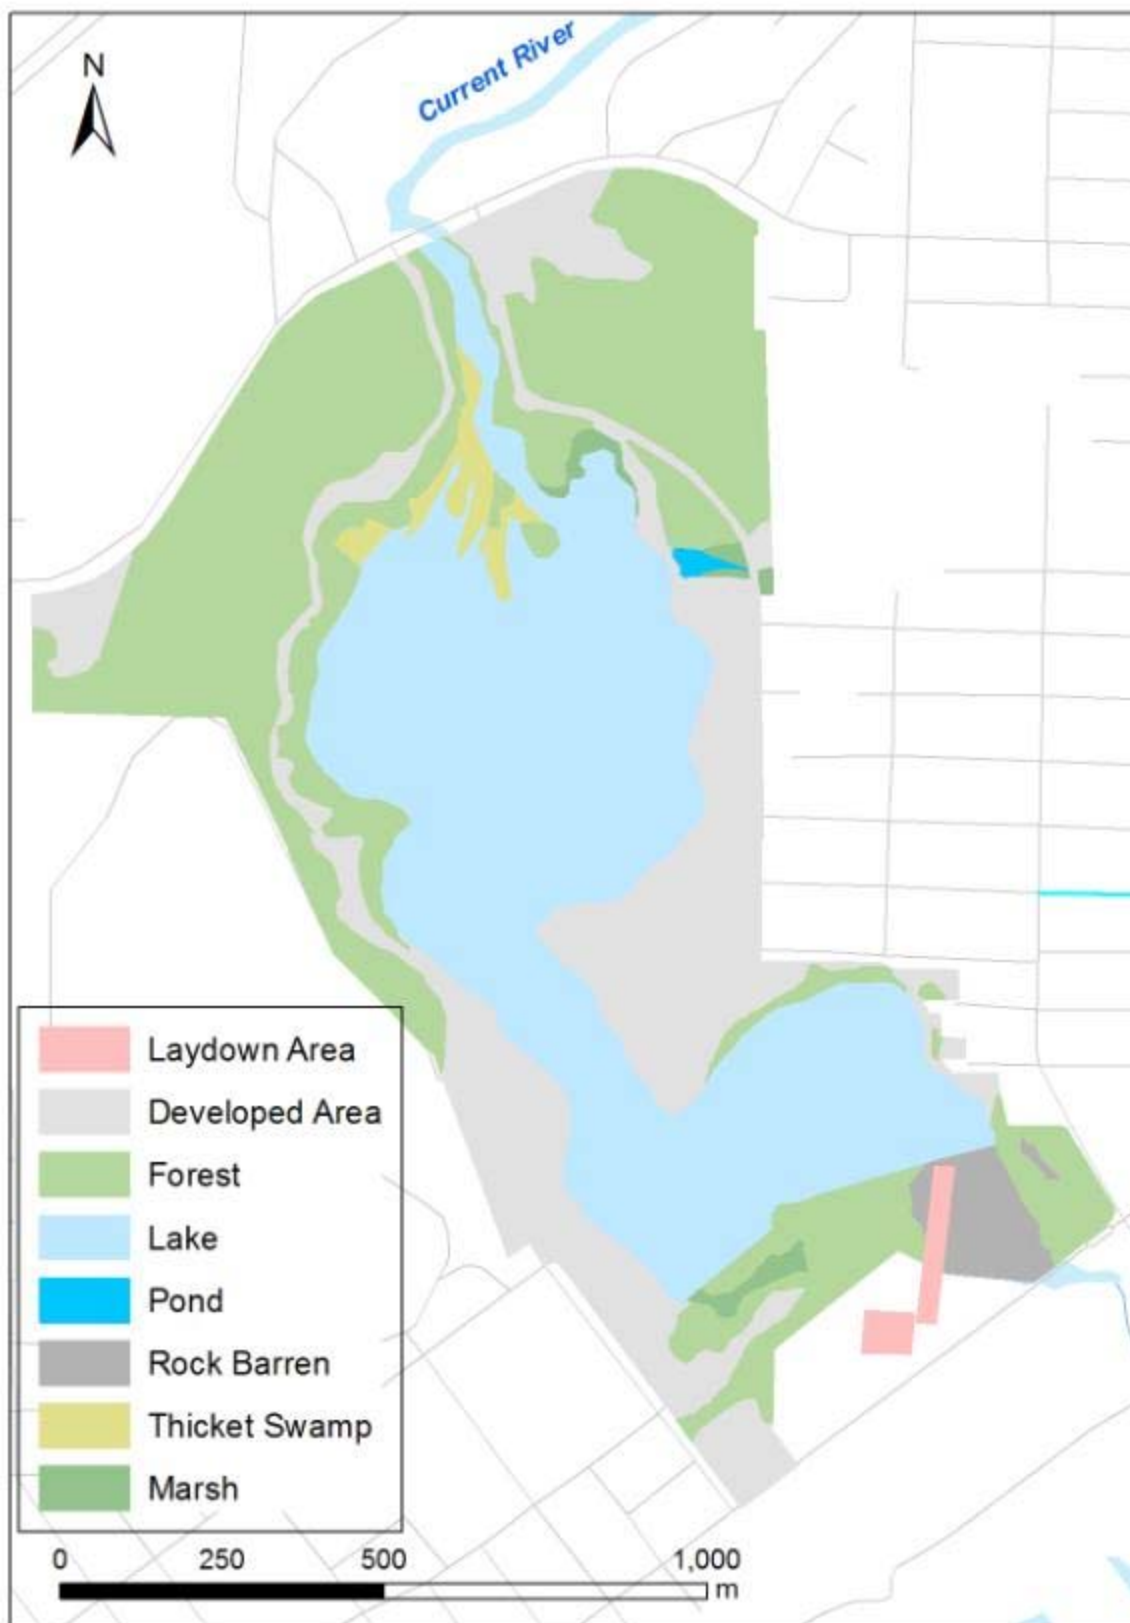
Figure 16. Vegetation map showing proposed laydown area. Boulevard Lake 2016.

Boulevard Lake Peak includes about 51 ha of forest cover, mainly at the north end of the park with a section below the dam (Figure 16). The largest forest blocks include two relatively contiguous patches of 13 ha and 22 ha.

The proposed laydown and access road area will be used during dam repair (Figure 16, Figure 19) and cover about 0.3 ha and 0.4 ha respectively below the dam.

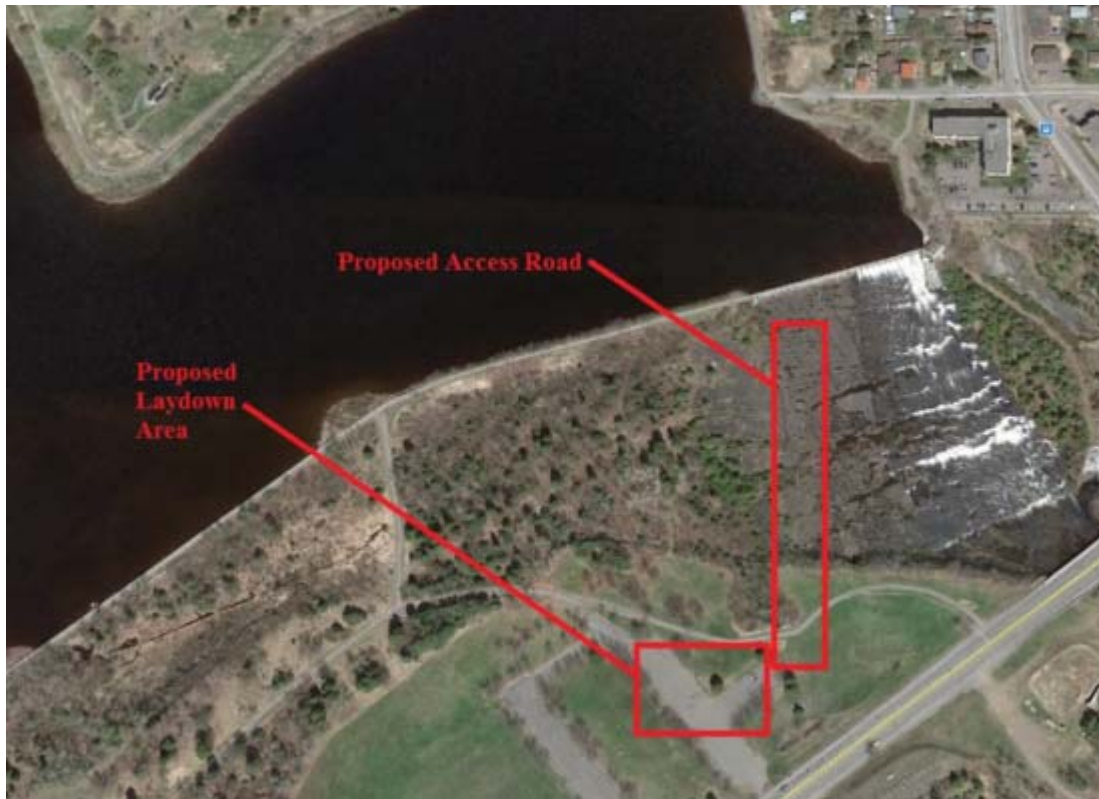
Figure 19. Aerial view of proposed laydown and access road area.

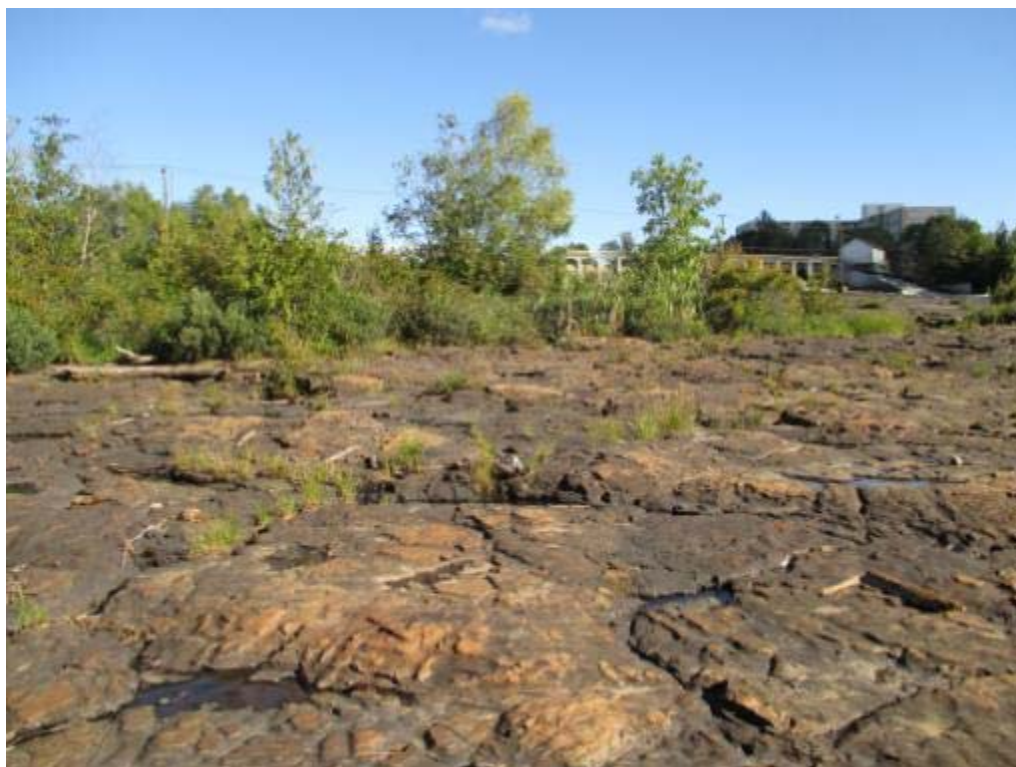
**Figure 21. North part of proposed access road showing rock barren on river floodplain.**

Rock barren (Ecosite 160; OMNR 2009) occurs on the bedrock shelf below the dam (Figure 21). This area is scoured by water flowing over the dam during high flows but is typically exposed for most of the year (Foster 2011). High flows have washed away most soil, organic material, sand and gravel. Patches of sedges and Sweet Gale are confined to a few deeper crevices. Some pools of standing water persist through the summer.

The proposed access road corridor is about 200 m long and extends from the laydown area to the dam. The southern third of the consists of lawn with some small (1 - 2 m) planted Red Pine and oak trees. The corridor crosses a narrow strip of forest consisting of mature (10 m tall) Balsam Poplar with a shrub layer of Red-osier Dogwood and Red Raspberry. Closer to the river, the trees become smaller as the soil becomes shallower and small White Cedar and White Birch (5 m tall) become common (Figure 21).

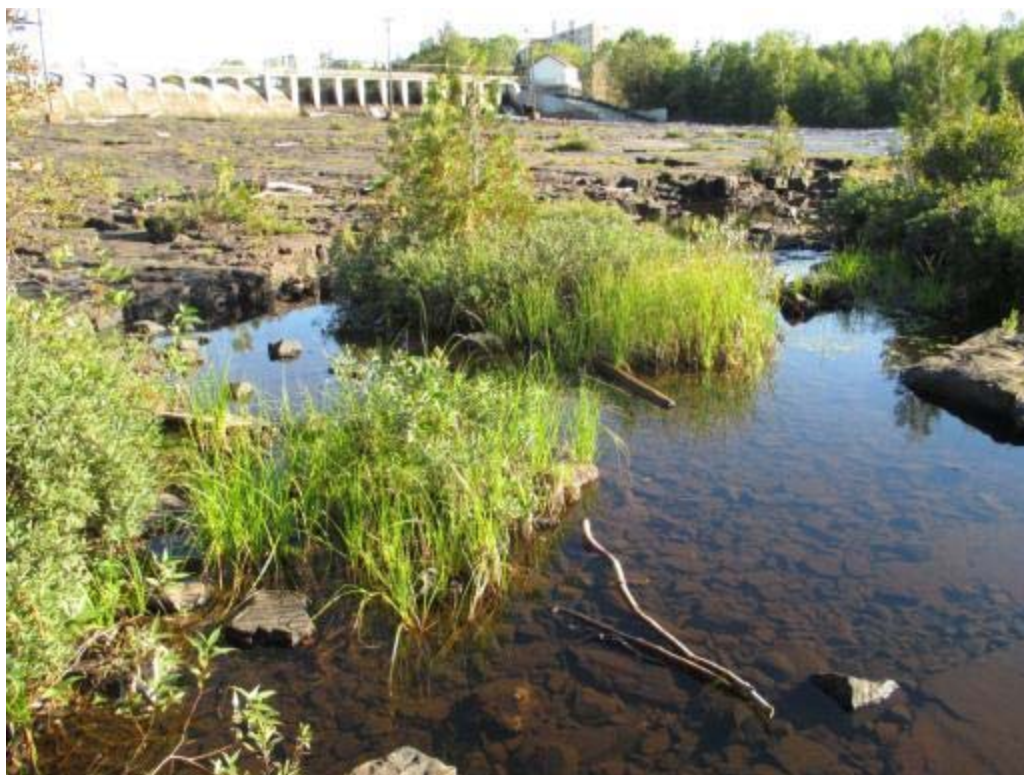
**Figure 22. North part of proposed access road showing pools of standing water.**

(Figure 22). Pondweeds (*Potamogeton* spp.) are present at low cover in pools. Seepage from a wetland to the north flows across the corridor. A seep with iron precipitate was noted about midway up the bedrock slope which appeared to be hydrologically feeding a small wetland.

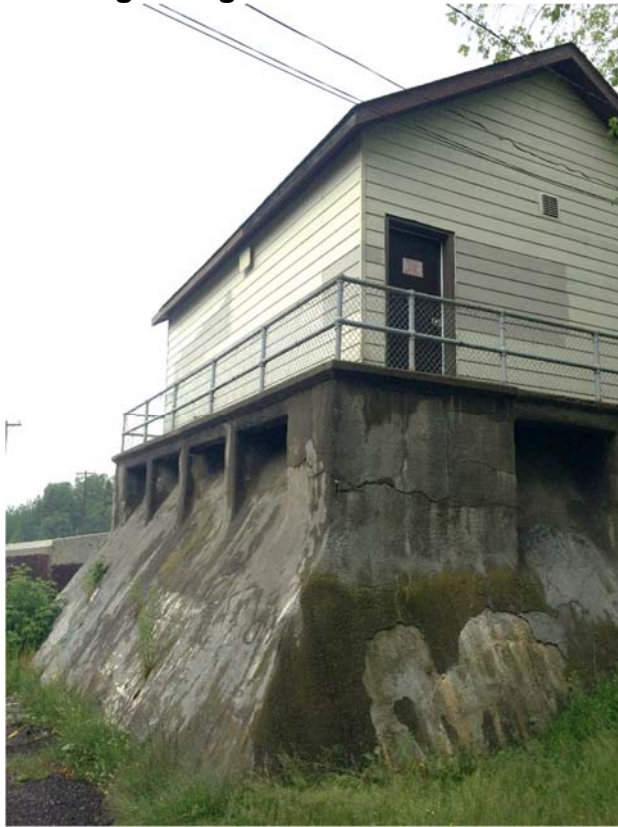
**Image 4: Wooden Clad Fish Ladder Building facing South**

There is an existing step pool fishway at the east end of the dam built in 1992 to provide a passage way for adult rainbow trout (steelhead) migration. The steelhead run typically begins in April and finishes by mid-June. A small wooden clad building sits at the east end of the dam above the fishway, on a concrete foundation (Images 3 – 4). Extending from this building, but buried, is the pipeline (Images 5 and 36) that feeds the power generating station house at the south end of the project area (Images 6 - 7).

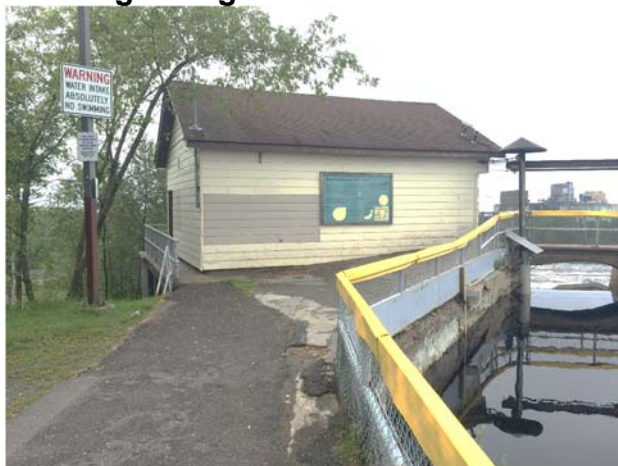
**Image 5: Buried Pipe Line facing NNE**

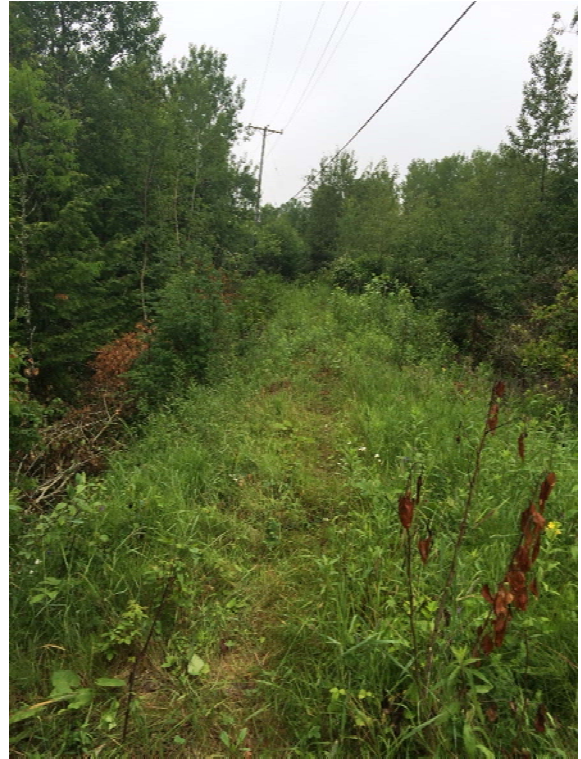
**Image 6: Power Station facing SW**

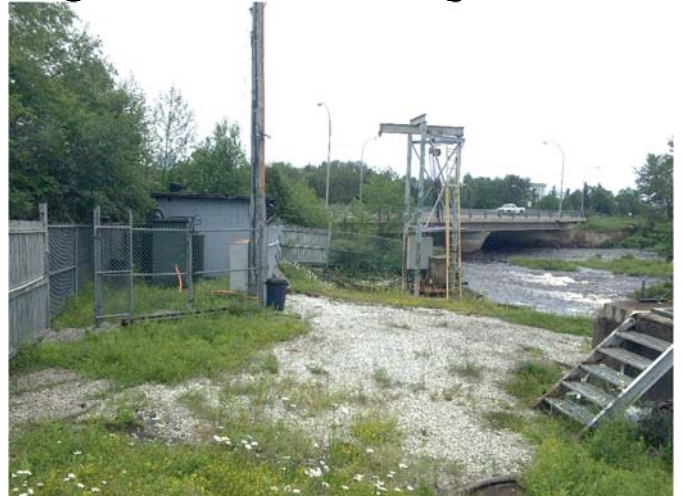
**Image 7: Power Station Enclosure facing SW**

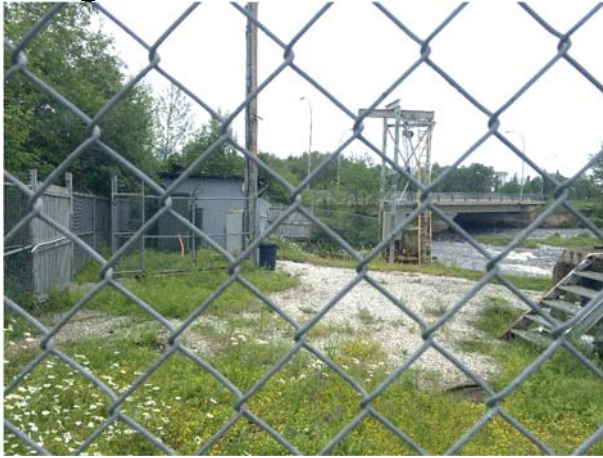
**Image 8: Dam from Boulevard Lake facing SW**

The concrete dam (Images 8 - 9) extends from the end of Boulevard Lake to the west about 112 m. During low water (partial draining of the lake) the dam was exposed showing it to be in need of repair (Images 10 -11). Below the dam on the west side of the Current River Falls is a concrete retaining wall (Image 12) measuring about 86.85 metres in length and about 14" (.1016 metres) in width at the top. On the north side of the retaining wall is a small creek and a very wet area. Also on the west side of the retaining wall and extending to the retaining wall itself and possibly under it, is an iron pipe that is partially buried, but a section of it has been exposed through excessive water action (Image 13).

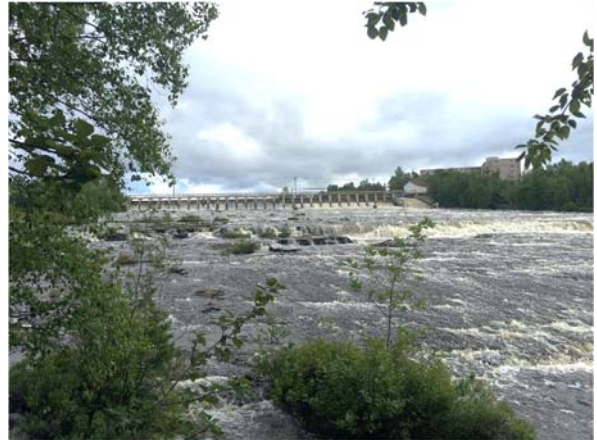
**Image 9: Boulevard Lake Dam facing N**

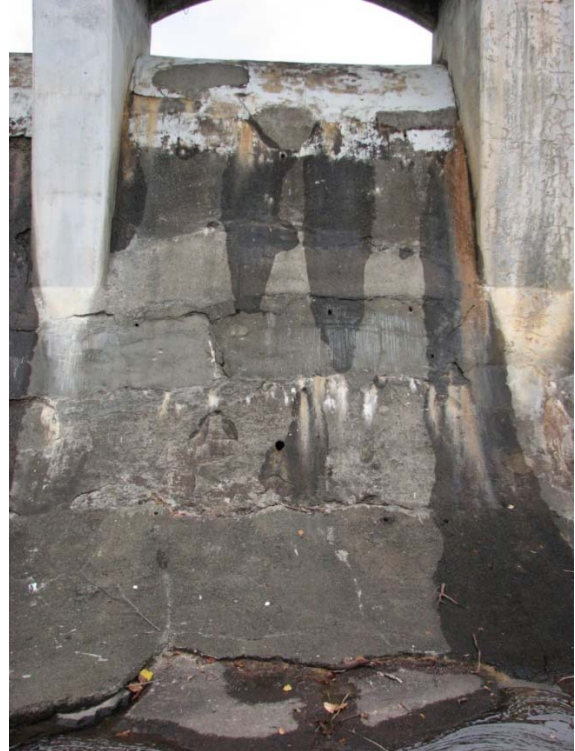
**Image 10: Dam in Poor Repair (from client October 15, 2008)**

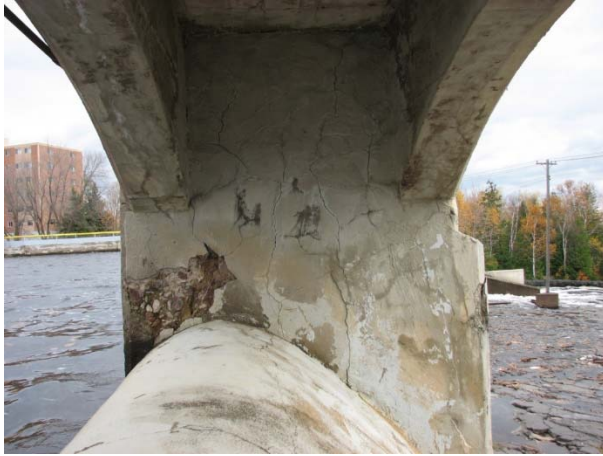
**Image 11: Dam in Poor Repair (from client October 15, 2008)**

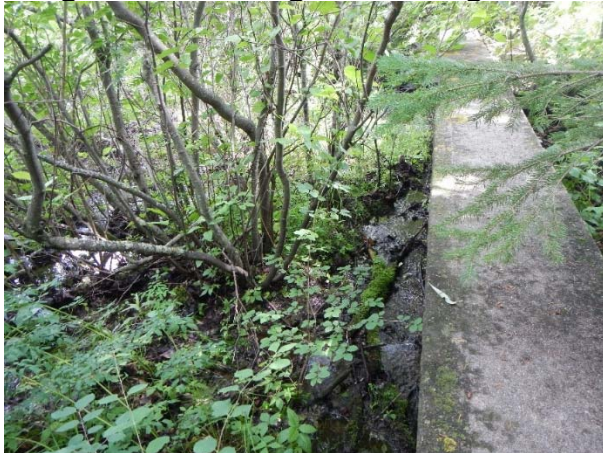
**Image 12: Retaining Wall facing E**

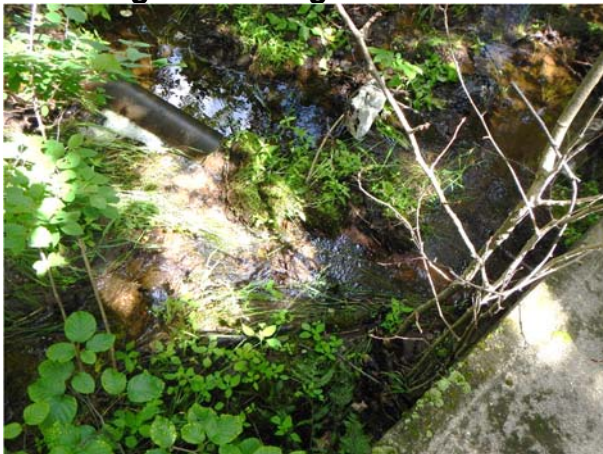
**Image 13: Iron Pipe intersecting Retaining Wall facing N**

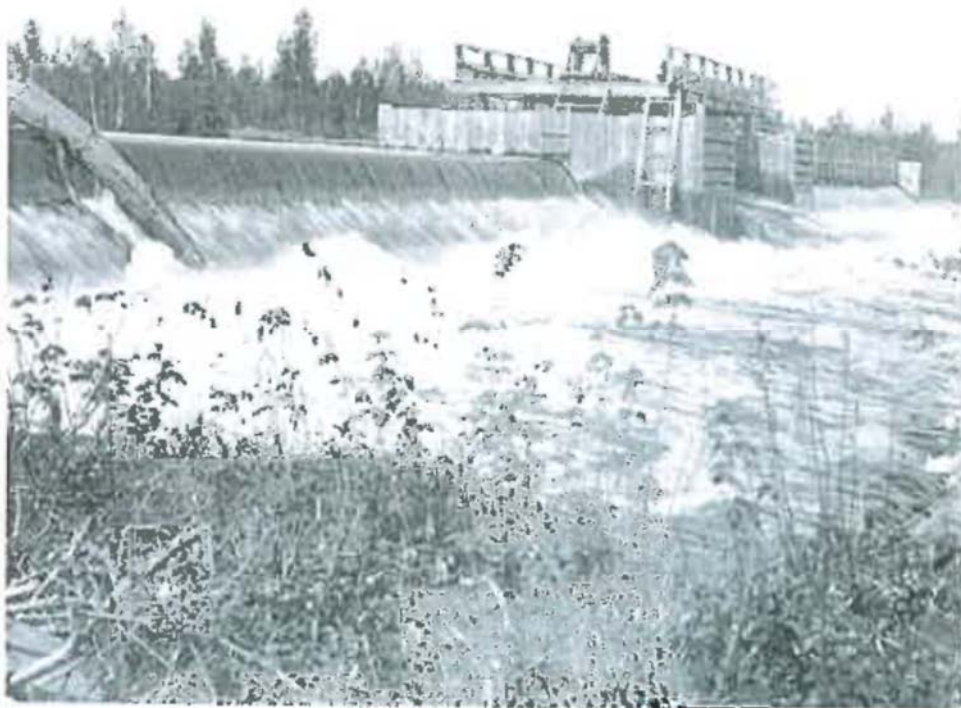
**Image 18: First Current River Falls Dam c. 1905** (from Bobrowicz 2012: 12)

penstocks which fed the converted generation station at the mouth of the river. The original dam stood eight feet high, and had a storage capacity of 15 million gallons (68,000 cubic metres) (Bobrowicz 2012: 10). Image 17 illustrates the Current River in the area of the fall prior to the first dam construction. The original dam, under construction, is depicted in Image 18. The power house (Image 19) is depicted from the CPR railway bridge facing north. The original power house was located off the study area.
