# SCHEDULE C MUNICIPAL CLASS ENVIRONMENTAL ASSESSMENT

Environmental Study Report  
for the Rehabilitation of the Boulevard Lake Dam

December 2018

Arcadis Canada Inc.

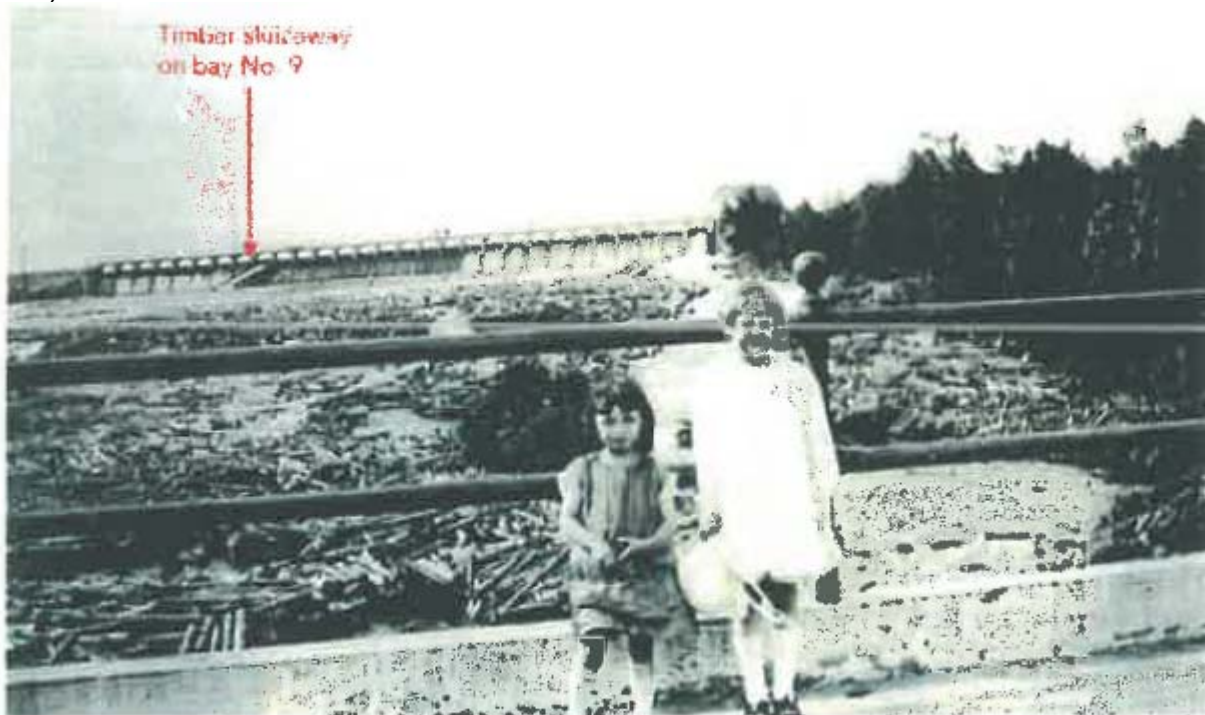
**Image 21: Timber Sluiceway No. 9** (this might be No. 10, not 9 [SJAI]) (Bobrowicz 2012: 27)

Current River Dam from Cumberland Street bridge during the spring log drive, c. 1930. Photo courtesy of Mr. F. Gauley.

In 1917, a local logger named W.A. Kyron used the **Rivers and Streams Act** of 1913 giving people the right to float timber in rivers and streams during spring, summer and fall, and requires an apron or slide to be provided in dams to allow timber to run down a sluiceway. The City of Port Arthur modified bay No. 9 of the dam to accommodate the sluiceway. Timber then began to be floated downriver by 1918 during the spring (Bobrowicz 2012: 22).

In 1925, the City of Port Arthur entered into an agreement with the Pigeon River Timber company to “manage the timber sluicing facility at the Current River dam” to assist with the Onion Lake area logging operations. In 1931, the Pigeon River Timber Company requests expansion of the timber sluicing facilities, and Bay No. 10 (Image 21) is opened to allow for additional timber to pass downriver each spring. “Guiding booms are installed below the dam to facilitate better passage over the bald rock” (ibid: 26-27). The spring log drives continue at this capacity until the late 1930's.

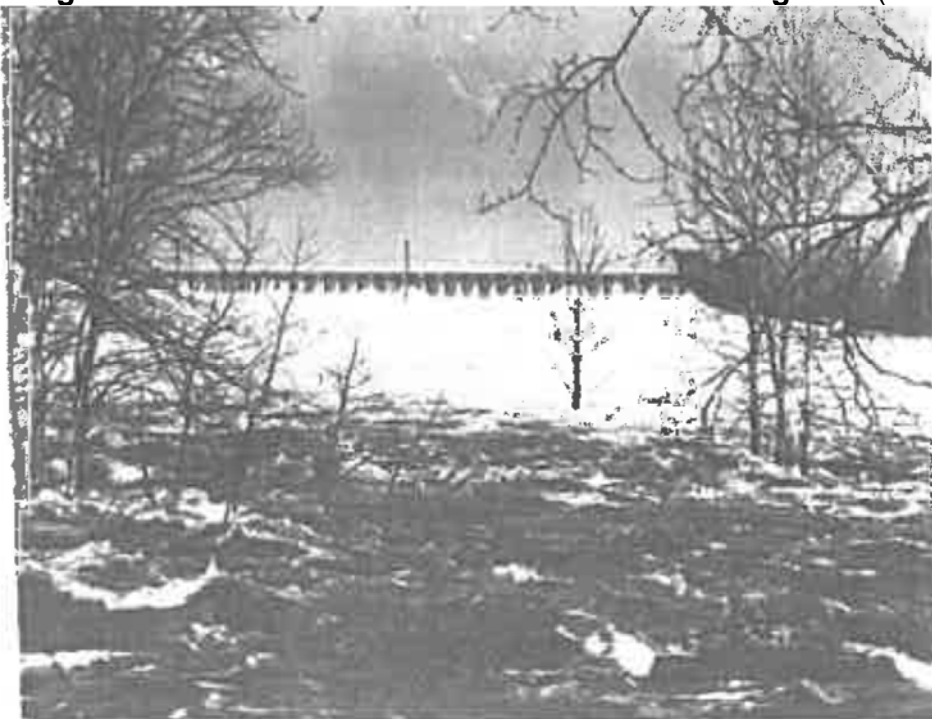
**Image 22: 1951 Flood at Boulevard Lake Dam facing NNE** (Bobrowicz 2012: 29)

On May 3<sup>rd</sup>, 1951, the Current River floods again (Image 22), reaching a “maximum peak flow of 11,400 cubic feet per second (323 CMS) at the Boulevard Lake Dam. This is the highest peak flow ever recorded at the dam, though it is likely that the 1908 flood was higher” (ibid: 29). The waters were so high that they crossed Cumberland Avenue and washed out both the CNR and CPR main lines. A year later (1952) the dam was repaired and enlarged. Alterations to the dam increased flow capacity and this was beneficial in a subsequent flood of equal flow in 1957, where no damage was reported.

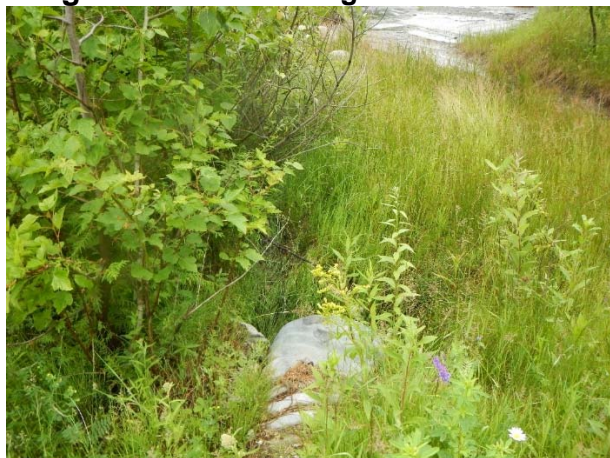
**Image 25: Culvert facing Northwest**

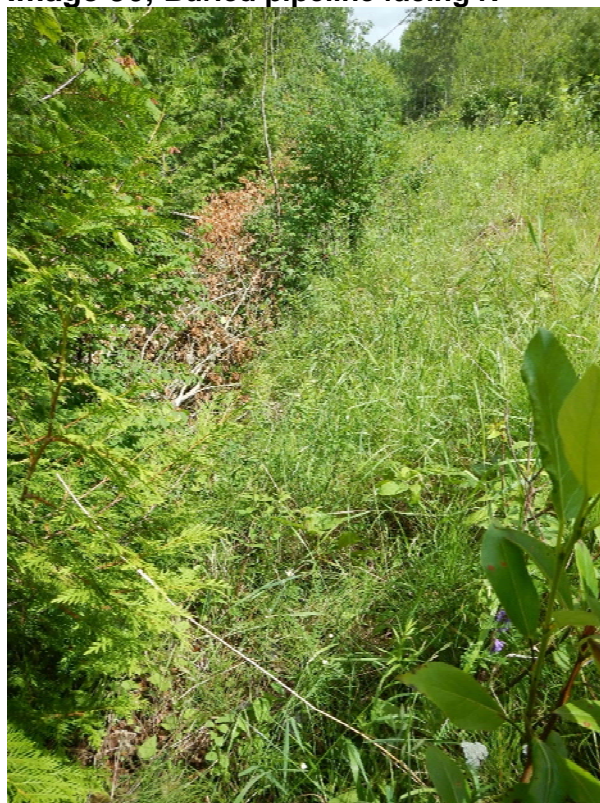
**Image 36; Buried pipeline facing N**

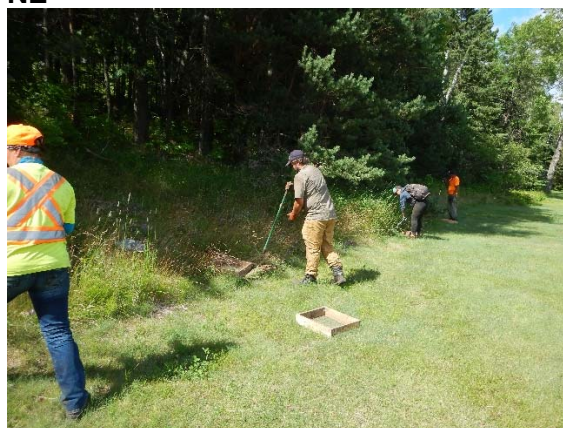
**Image 49: Planview of Test Pit/Unit 2 facing 304°**

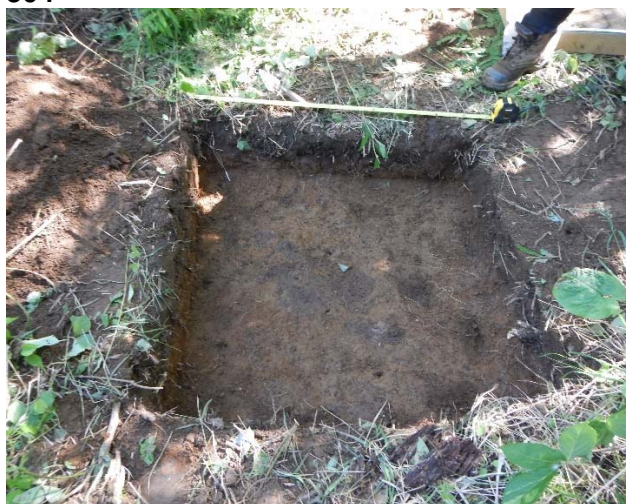
**Image 54: Positive Test Pit #1 – Test Unit Planview and Profile**

The 2016 investigation relocated the site with two positive test pits located close to each other. Both of these positive test pits were further intensified with eight (8) additional test pits spaced at 2.5 m intervals from the positive test pits (see supplementary documentation). There were no additional positive test pits. A one metre square was placed directly over the centre of each test pit. The test units were excavated into sterile subsoil. There were no features located in either unit, although in the wall of Test Pit/Unit 1, a pocket of chert (without definition of soil stratigraphy) was located at the interface of the topsoil and subsoil (Images 54 and 55 illustrate the drawn planview and profiles for each test unit, and Images 49-52 illustrate the photographs of the same). There was no stratigraphy other than the organic decomposed layer of forest vegetation over a sandy subsoil. Test Pit/Unit 2 produced a much smaller quantity of material (n=12) compared to Test Pit/Unit 1 (n=715). Both test pits/units produced modern material, which is not surprising given that the area was littered with garbage on the surface, recent and very recent (that is, someone bedding down adjacent to the site).

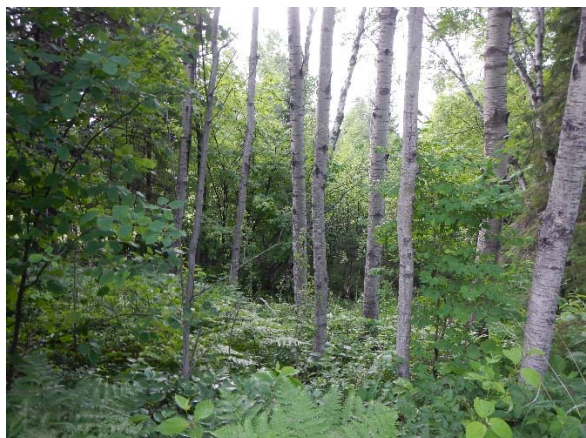
**Image 57: Disturbed area – gravel facing NW**

A large disturbed area was found through standard interval (5 metre) test pitting. It was located north of one of the pedestrian/bicycle pathways and between a permanent wetland to the north. The area was disturbed as observed from surface conditions of gravel and concrete (Images 57 - 59), and a deposit of large rocks. This area was subject to test pitting in five metre intervals, and positive test pits were further intensified with an additional four test pits around each positive test pit spaced at 2.5 metre intervals (Map 21).

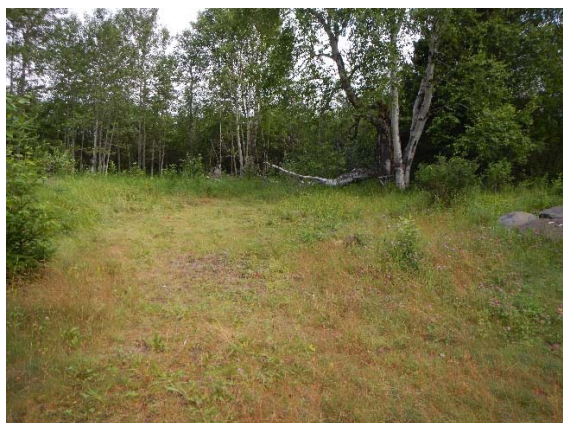
**Image 58: Large redeposited rock pile facing ENE**

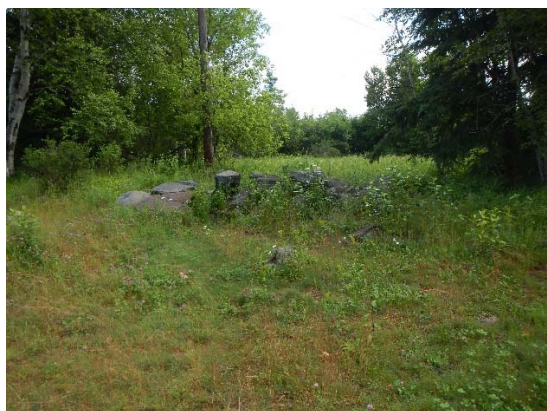
**Image 59: Disturbed soils facing down**

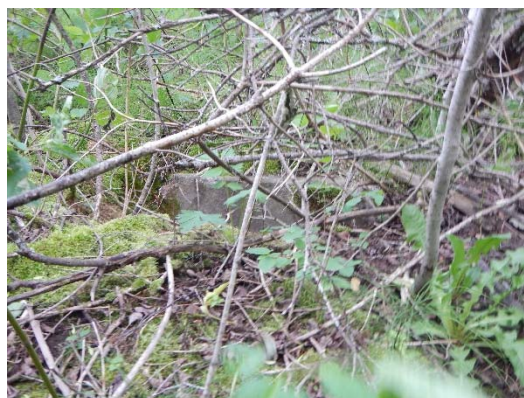
**Image 72: 20 degree plus slope – not tested facing NW**

The study area encompassed approximately 11.78 hectares. Exposed areas of bedrock were pedestrian survey methodology conducted in five metre intervals (Images 23, 26, 38, 40-44), and accounted for approximately .83 ha (7%) of the study area. Steep slopes in excess of 20° were documented (Images 35, 47, 72-73) but not subject to test pitting (.63 hectares, 5.3%). Permanently wet areas (Images 27, 29, 30, 39, 62, 68, 70, 78-79, and 82-83) were not tested (3.35 ha, 28.4%). The remaining areas (59.3%) were subject to test pitting in 5 m intervals. In addition, some areas were subject to intensified test pitting (Image 76) conducted in 2.5 m intervals (.08%).

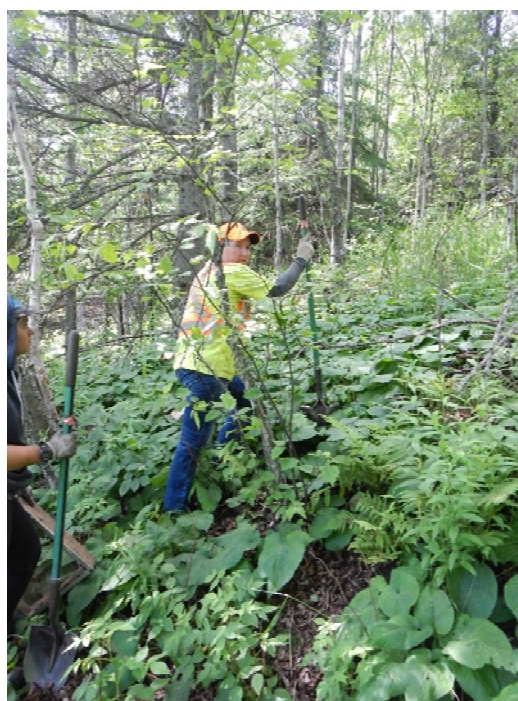
**Image 73: 20 degree plus slope along dam – not tested facing S**

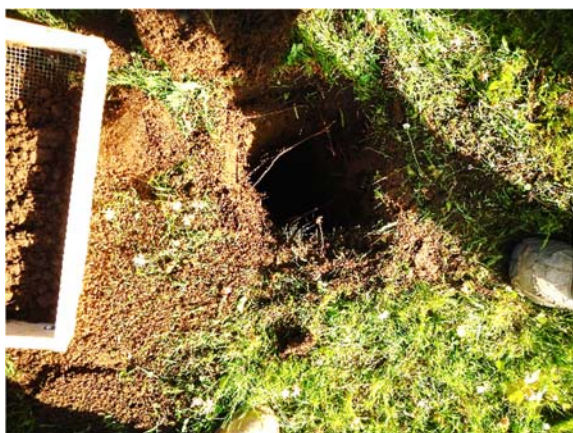
**Image 76: Intensifying test pitting around positive test pit 1 facing WSW**

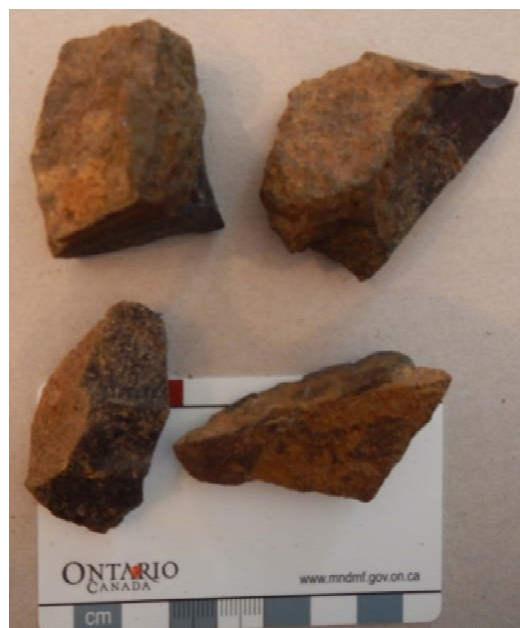
**Image 91: DcJh-21 Examples of Secondary Flakes**

There were 13 pieces of decortication, 44 primary flakes, 120 secondary flakes, 527 pieces of shatter, two cores, and the one scraper (described above). Images 89 to 96 illustrate some of the materials recovered from the site.

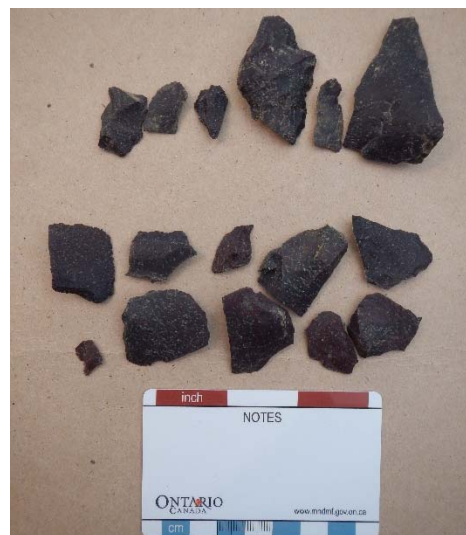
**Image 90: DcJh-21 Examples of Primary Flakes**

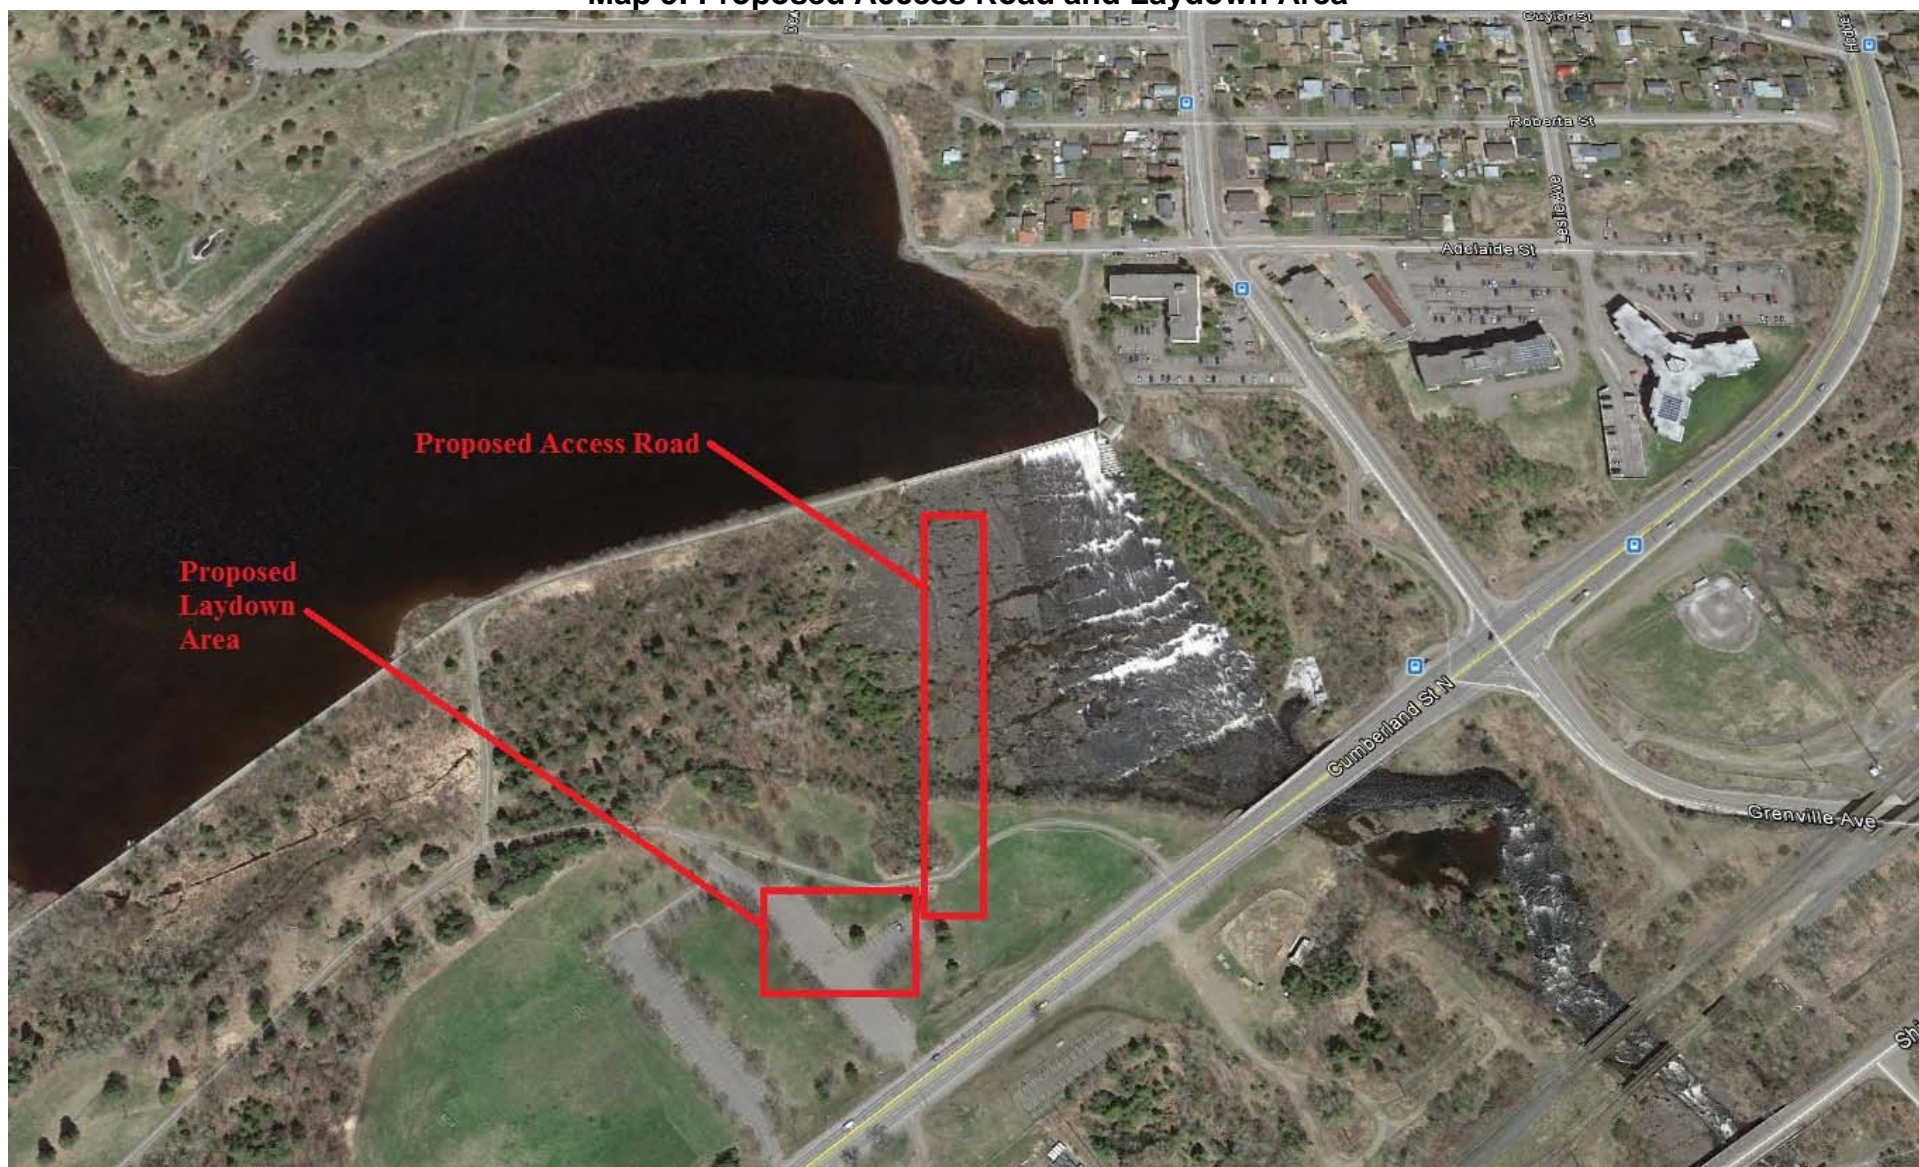
Map 5: Proposed Access Road and Laydown Area
