Bank of Commerce
409 Victoria Avenue

Heritage Registry; Designated Property No. 22

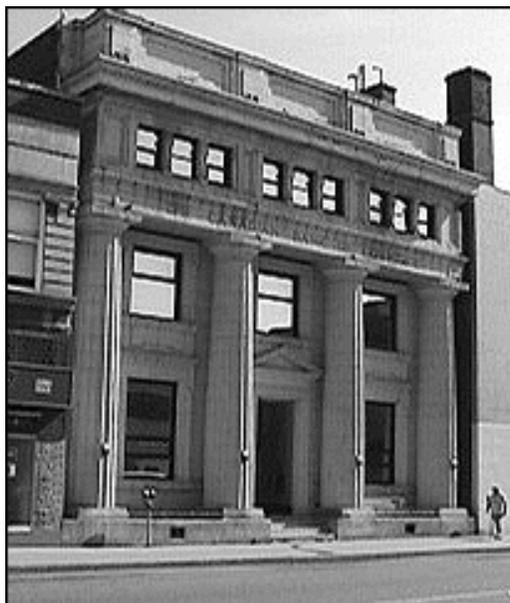
Notable Features: Twenty-five foot Doric columns

Bands of relief ornament framing the entrance

Built in 1910-11 as the Bank of Commerce, this three-storey building is a prime example of Beaux-Arts classicism with its' four large scale columns and the consistent detail of classical motifs. Its façade was described at the time of construction as "Grecian Doric design," and the twenty-five foot columns are Doric, fluted and massive in appearance. Unlike Greek columns, these are not free-standing, but rather are extensions of the façade wall. The columns appear to support an overhanging third storey functioning as a frieze, but with windows, and a parapet with buttresses defines the roof.

A pediment is placed over the entrance rather than above the columns. Bands of relief ornament frame the entrance and the windows; the ornament includes the egg-and-dart, and the anthemion patters, a stylized floral design. The rather free interpretation of classical motifs and the impressive scale of the building identifies it as an example of Beaux-Arts classicism. The façade is terra-cotta, originally silver grey in colour; the terra-cotta (fired clay) was imported from Leeds, England. Terra cotta allowed for the elaborate detailing and fire proof construction. The original doors were of bronze and the cornice was of copper.

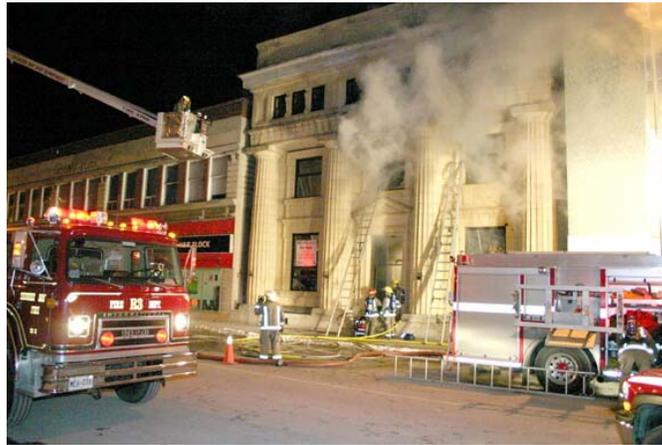
Fire at the old Bank of Commerce, Feb. 8th, 2007

It was an 'eight-alarm' fire emergency, with over 30 firefighters called to the scene. The frigid -20 degree February weather made it difficult to fight the flames, but the firefighters were able to have it extinguished by the end of the night, with one minor case of frostbite as the only injury. The majority of the building was completely destroyed, but an examination by a building engineer confirmed the structure's foundation was not damaged and many of the support beams were in good condition. Along with burnt walls and a collapsed roof, most of the damage was from water used to beat down the fire. "That building is very repairable," Bordynuik said. But he conceded that the restoration would be an expensive and time-consuming effort. Ultimately, the cost and effort would be too great and Bordynuik would be issued a demolition permit.

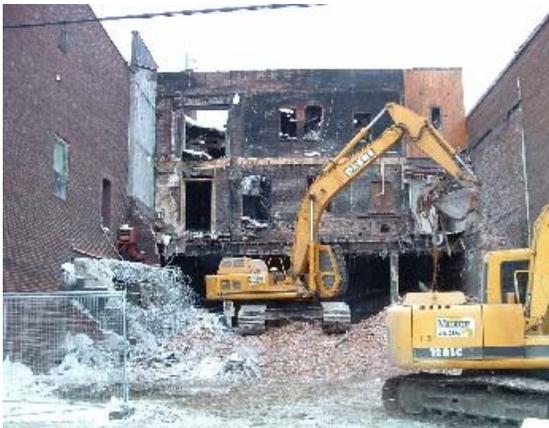
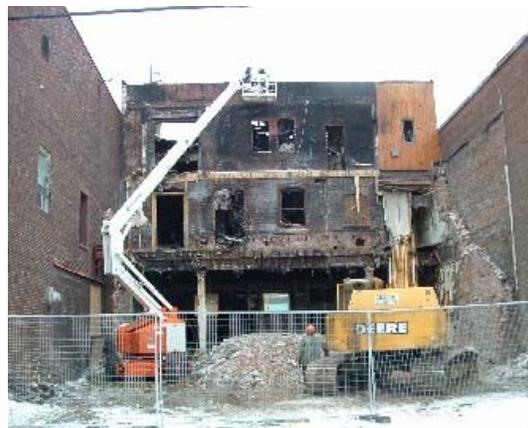
Demolition pictures; Saving the Façade

The silver lining of this tragic tale is that the façade of the Bank, which had been a major architectural feature in the designation of building as a Heritage Site, was salvagable. The demolition crews were able to tear down the back of the building, while leaving the front wall standing. Currently, the space is vacant, but any proposed structure will have to incorporate the of Bank of Commerce façade into the design plans.

Luckily, the façade of the bank was able to be saved after the devastating fire which ravaged the rest of the building. It was necessary for demolition teams to tear down the building because of health and safety concerns, but with careful work they managed to save the front façade, which will be incorporated into any future development on this site.
