32 Emmerson Ave.

## Architectural Analysis:

### 32 Emerson Ave.

**Significance Rating: A    Compatibility Rating: A    Materials Rating: A**

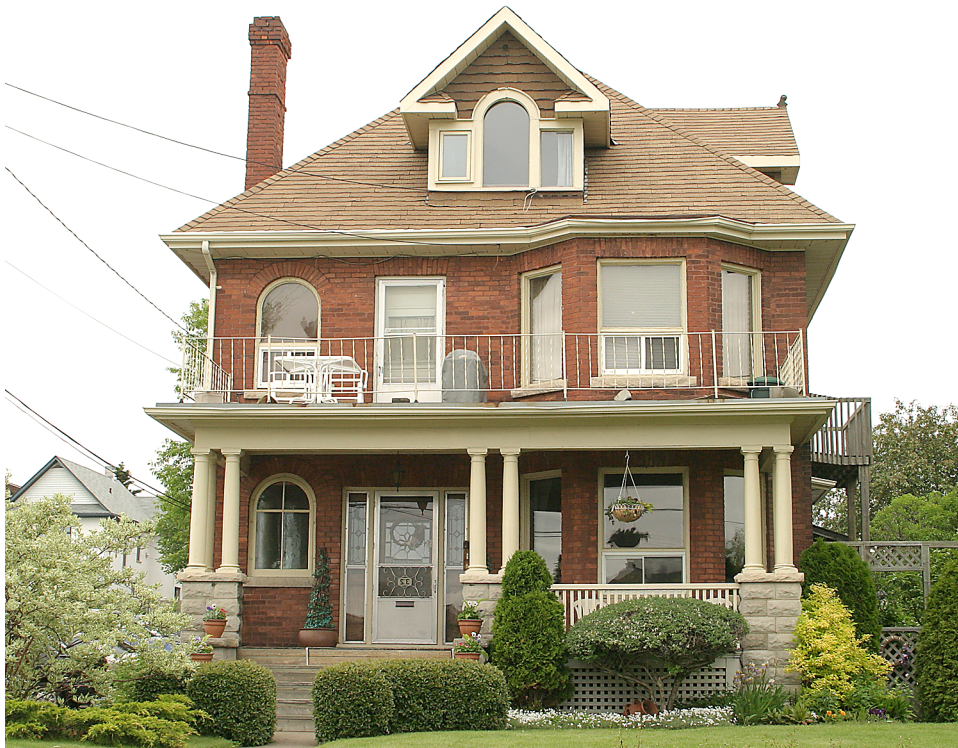
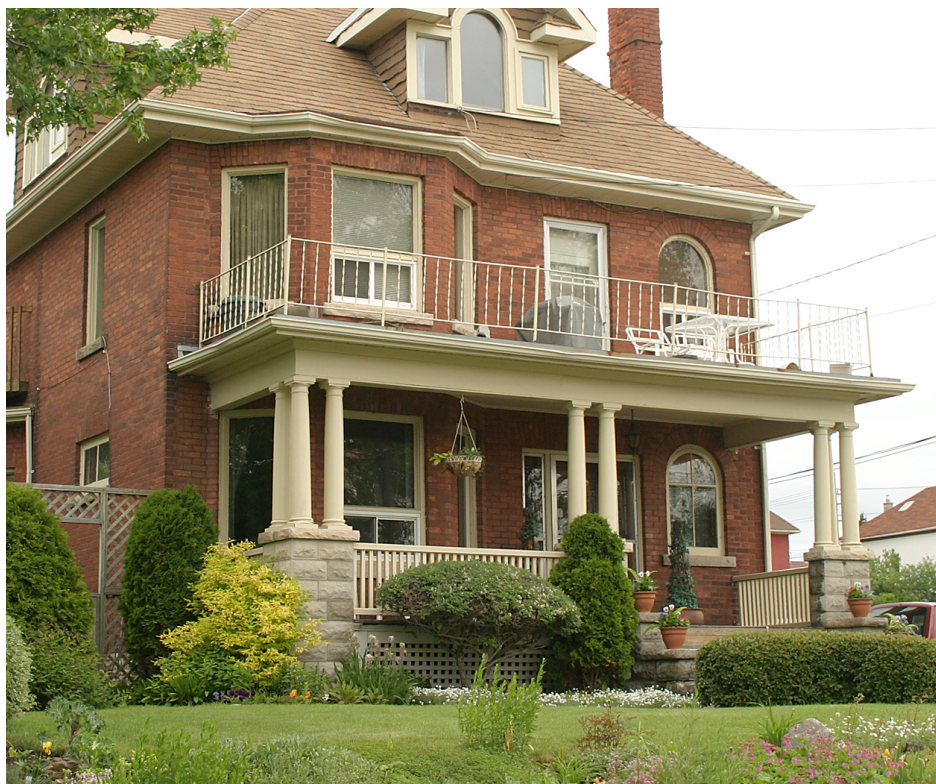
- 2 ½ storey
- The exterior walls of the house are brick veneer
- Base of front porch is stone
- Flat and arched brickwork surround windows
- A three sided tower like projection at the front (2 storey) and the side of the house (1 storey)
- A smaller second floor balcony on the south side

- Cross hipped roof design
- Asphalt shingles
- Gabled dormers
- Flat roof over the porch acts as a second floor balcony

- Windows are single hung, double paned sliding, square casement and arched fixed types in varying sizes.
- A thick molding surrounds the upper windows on the dormer

- The property is beautifully maintained and landscaped
- 8 Romanesque Columns adorn the front porch area
- The Chimney has a corbelled topped
