30 Emerson Ave.

## Architectural Analysis:

### 30 Emerson Ave.

**Significance Rating: A    Compatibility Rating: A    Materials Rating: A**

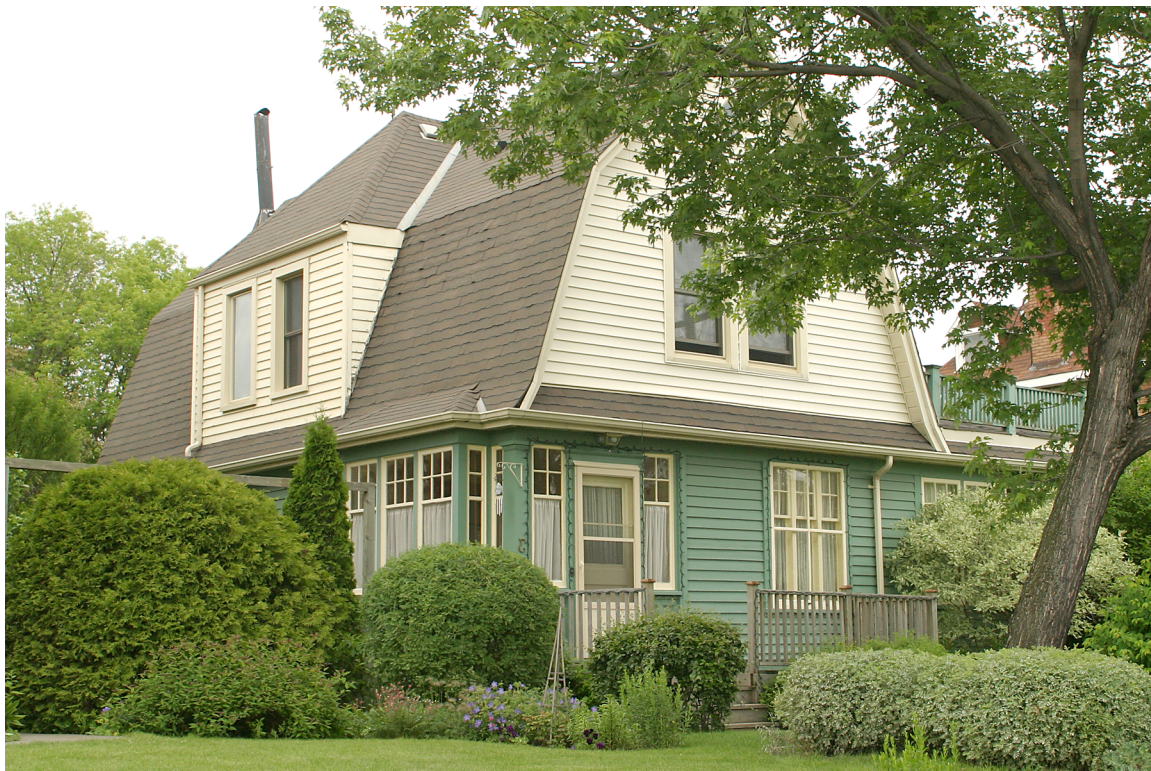
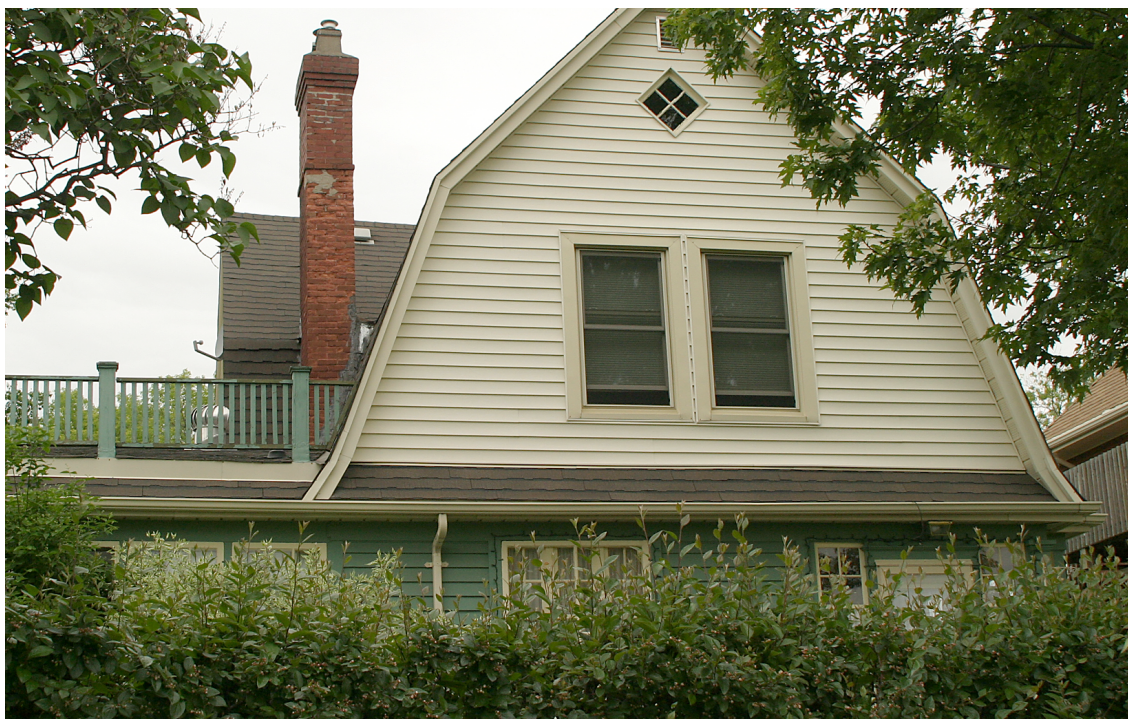
- 2 storey
- The exterior walls of the house are covered with siding, main floor is green in colour and the second floor is beige
- Sunroom was added in 1924
- The roof over the sunroom is used as a balcony for the second floor

- At the front of the house the roof is a gambrel design type, but towards the centre of the home the roof is a hipped design
- Asphalt shingles
- Asphalt shingle covered skirting at the bottom of each gable and the circumference of the sunroom just below the railing of the balcony

- Windows are single hung and casement types in varying sizes. Some are double paned sliding and single hung types

- There is a square diamond designed window on the second floor of the house, facing Emerson Ave.

- molding surround most windows

- The property is beautifully maintained and landscaped
- The trees on the property add to the overall ambience of the home
- The corbelled topped brick chimney that is prominent on the south side of the home was added in 1924
