29 Emmerson Ave.

## Architectural Analysis:

**29 Emmerson Ave.**

**Significance Rating: B+    Compatibility Rating: A    Materials Rating: A**

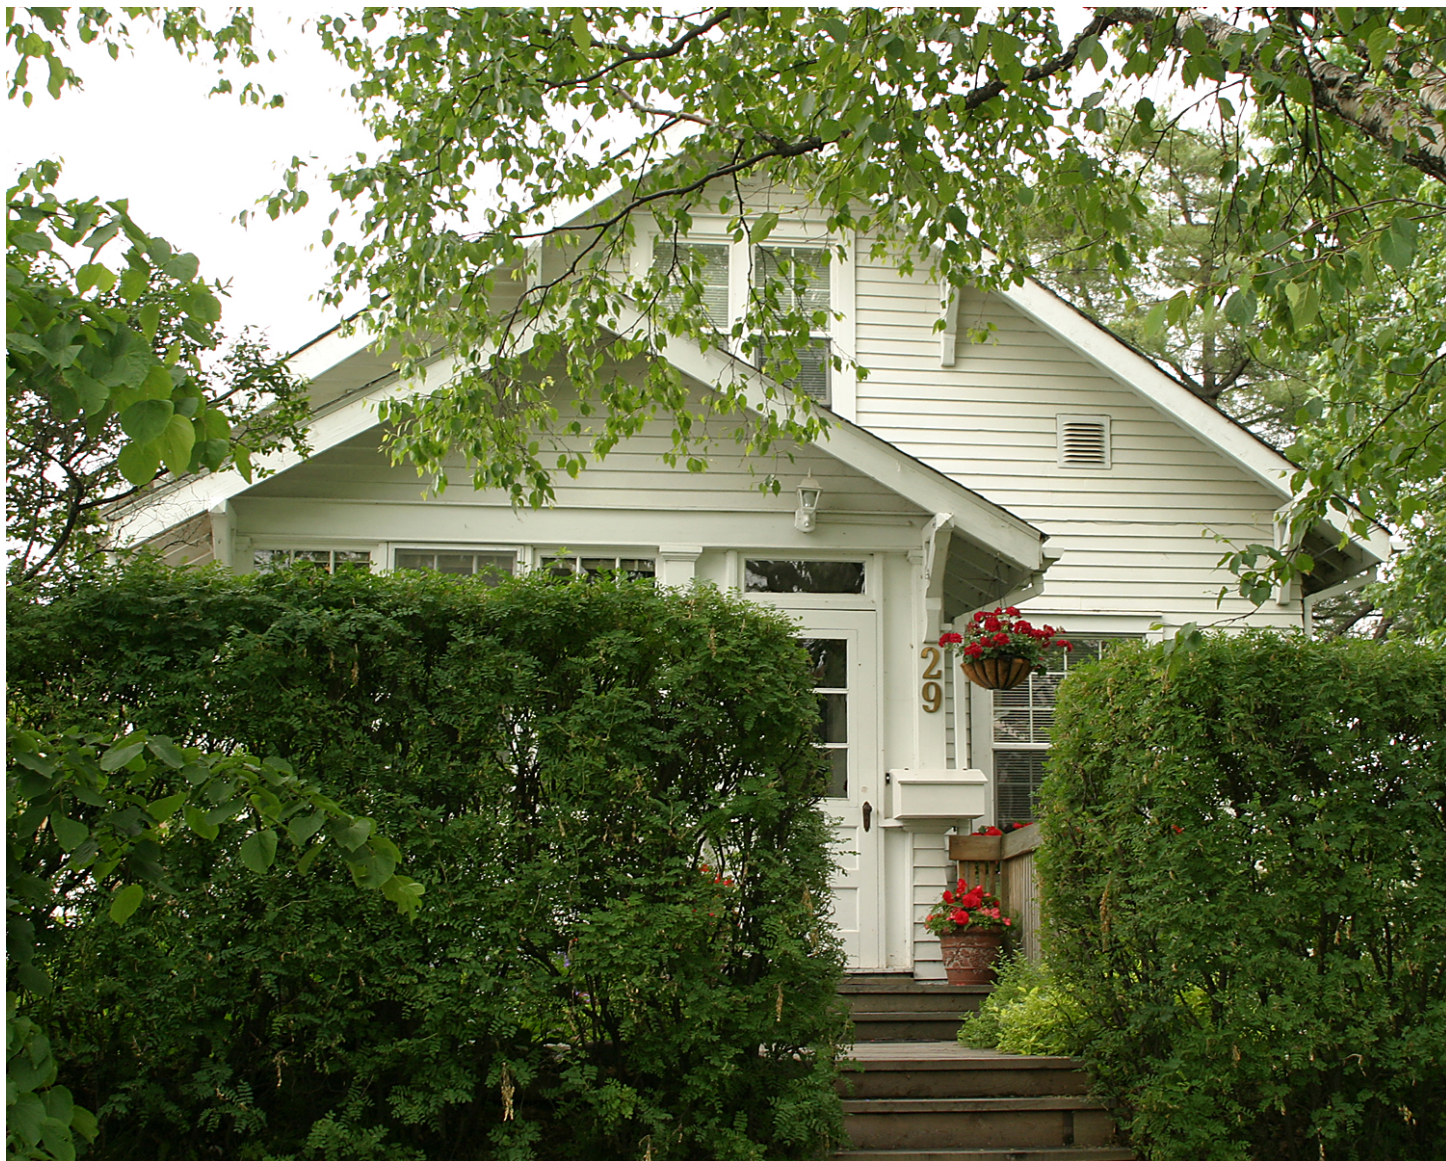
- 1 ½ storey
- The exterior walls of the house are covered with siding which is what the original building permit of the home lists
- Concrete basement
- Front porch area also has siding on its exterior walls

- The roof is a gable design type
- Asphalt shingles
- Roof over the porch area is of a gable design
- Decorative brackets

- Windows are casement types in varying sizes. Some are double paned sliding and single hung types with cross hatched patterns in the panes
- White molding surround the windows

- Front porch area's upper portion are all single hung windows with cross hatch patterns across each pane

- The property is well maintained and landscaped
- The house appears to have remained as designed in 1923
- The trees on the property add to the overall ambience of the home
- Estimated cost to build the home \$2500.00
