294 Harrington Ave.

## Architectural Analysis:

### 294 Harrington Ave.

**Significance Rating: A    Compatibility Rating: A    Materials Rating: A**

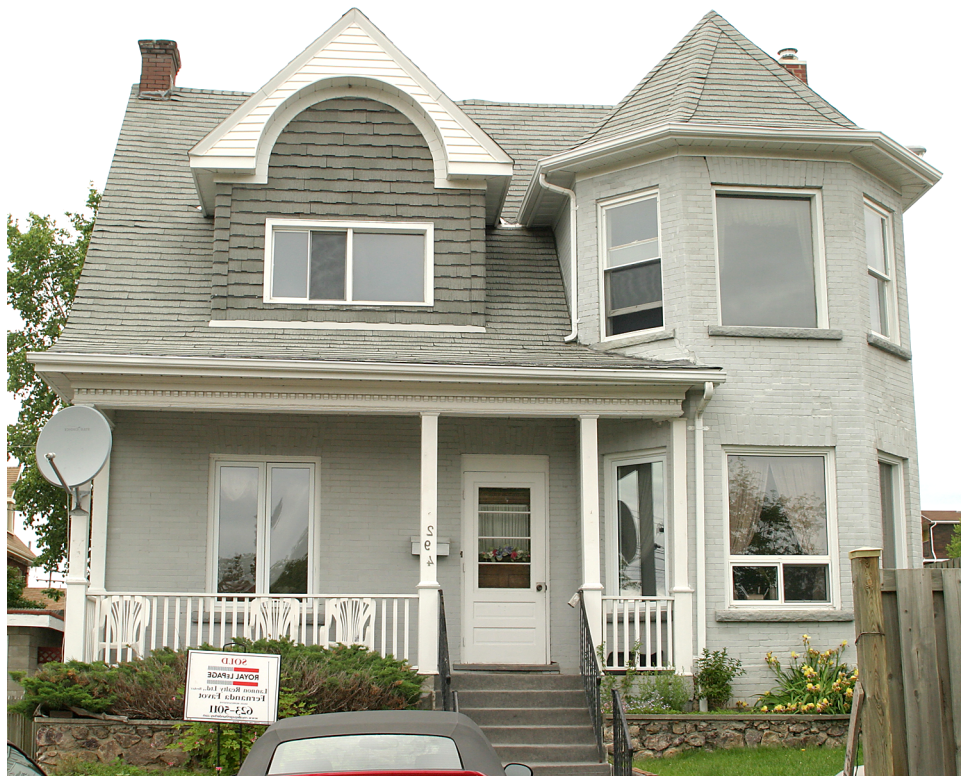
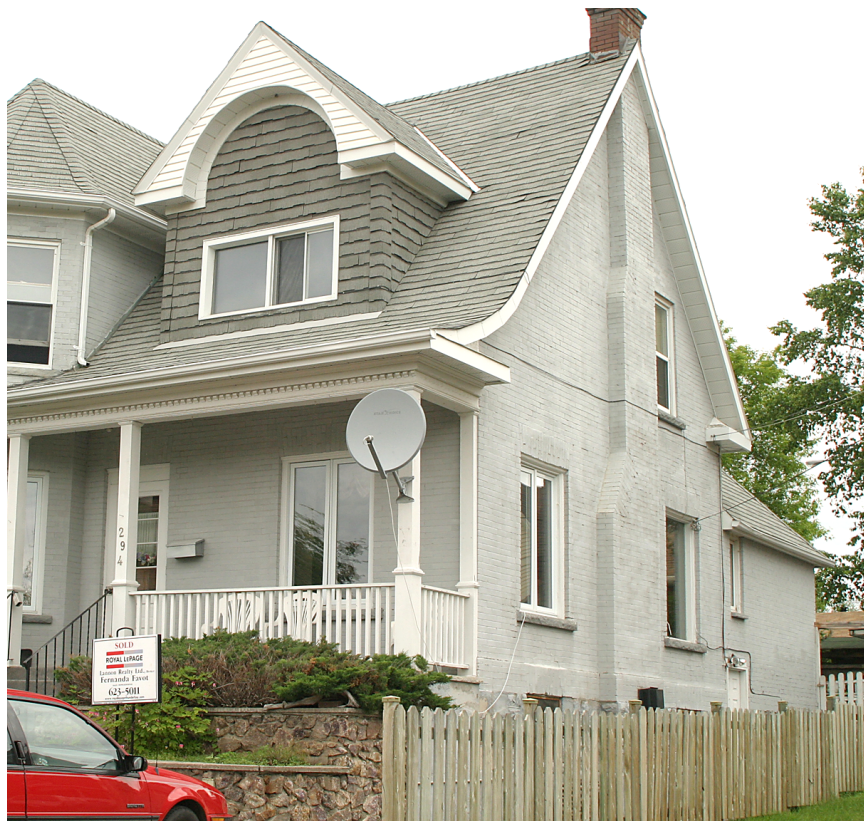
- The main building is 1 ½ storey
- A hexagon shaped, 2 storey semi detached tower is prominently located at the south west corner of this home
- The exterior walls are brick veneer that have been painted grey
- The keystones over the windows are of a herringbone design
- Window sills on the majority of windows are sandstone

- Small verandah area at the front of the house

- Cross gable design
- Gabled dormer on the south side of the house that faces Harrington Ave.
- Asphalt shingles on main roof
- Gable end is covered with asphalt shingles that are of a slightly different design than the main roof
- The lower portion of the roof slightly arches over top of the verandah area
- The fascia board on the gable end of the dormer

has an arch design and is covered with siding

- This building has a variety of different windows –single hung, sliding, casement, and fixed type designs

- Four square columns and a wood railing surround the verandah area
- Crown dentil molding just below the soffit and fascia of the verandah roof
- The top of the brick chimney is corbelled
