18 Emmerson Ave.

## Architectural Analysis:

### 18 Emmerson Ave.

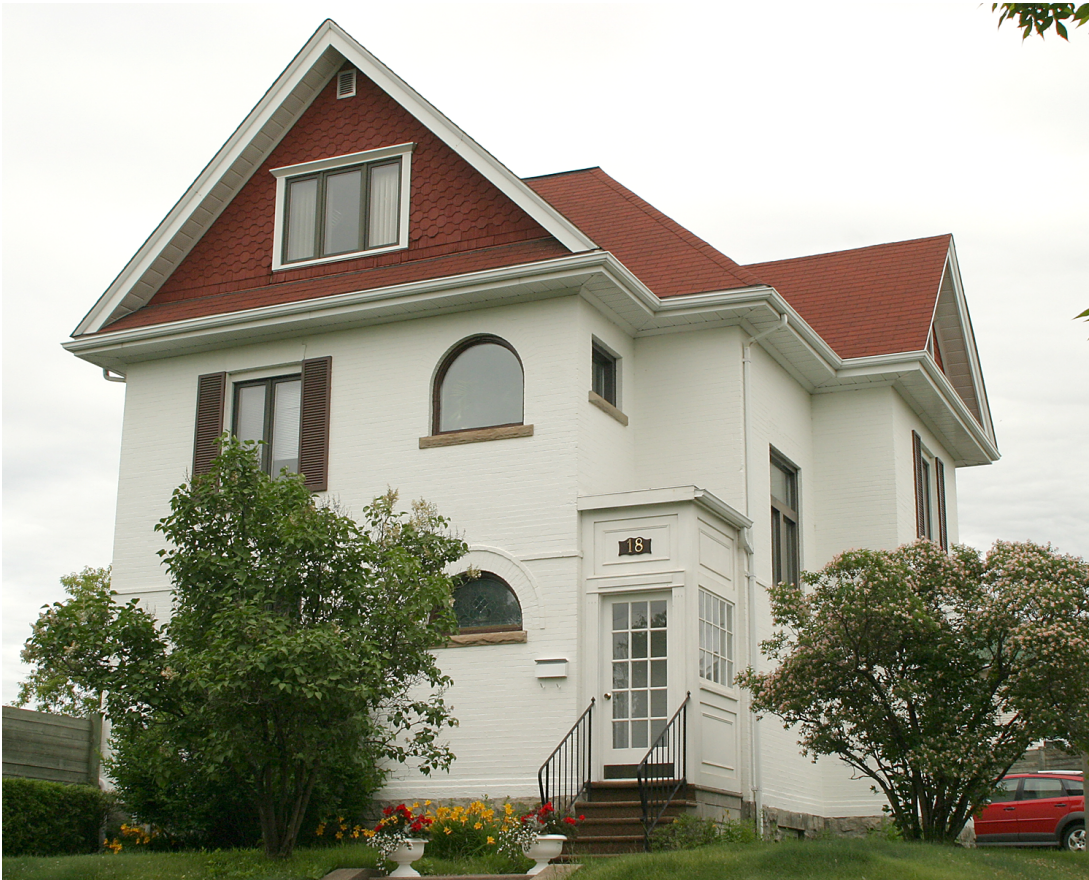
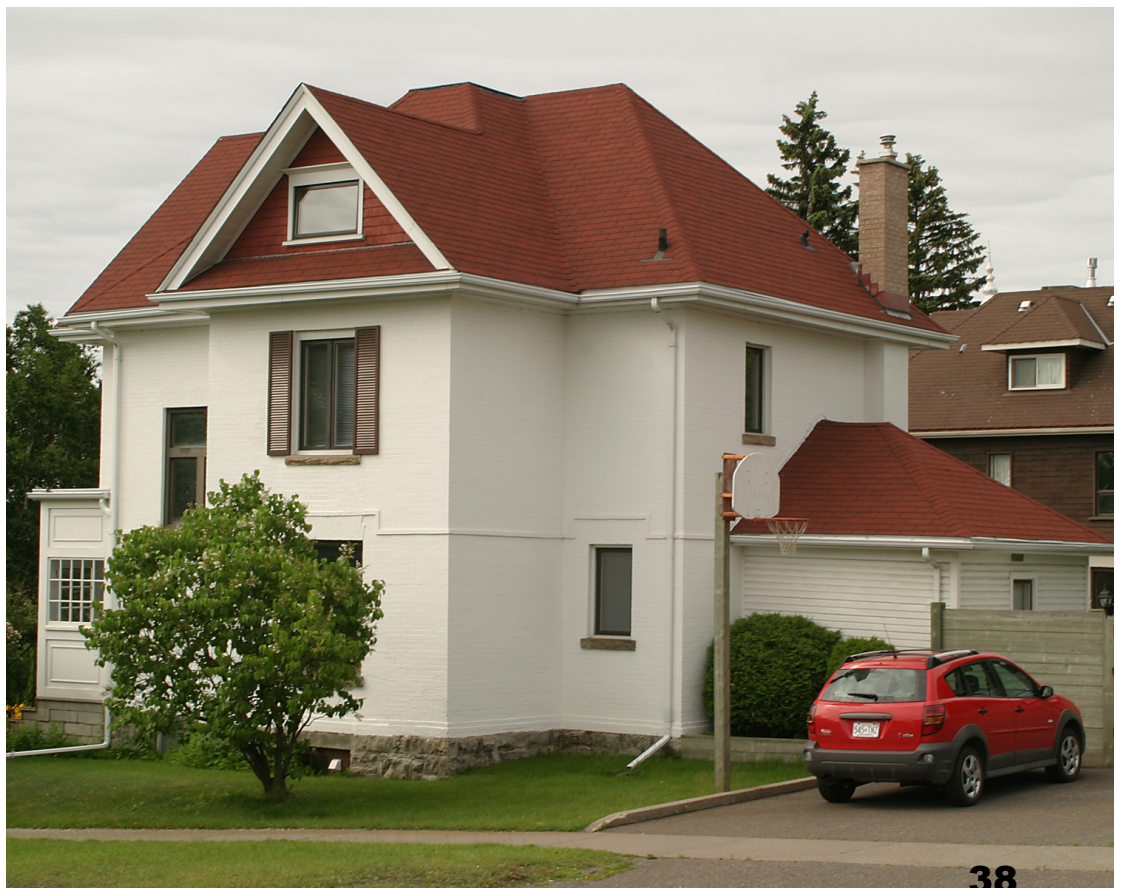
- 2 ½ Storey

- The exterior walls of the house are brick veneer that have been painted white

- Arching brickwork frames two on the front windows, one of the first and one on the second floor

- Brick stringcourse between the first and second floors

- Sandstone window sills

- The front portion of the house has a hipped roof, the addition added to the back of the home has a pyramidal roof design

- The roof design has two gable ends, one facing Emmerson Ave. and the other Harrington Ave.

- The gable ends of the home are decorated with cut and coloured cedar shingles in a horizontal geometric pattern

- Two arched windows adorn the front of the house

- The porch casement type windows have a cross hatch pattern

- Upper floor windows have decorative moldings and some of the second floor double casement windows have louvers
